Santa Barbara Airport

August 24, 2023

Conditions and Further Use Analysis Study for the General Western Aero Hangars,
Buildings 248 & 249.

LMA Architects

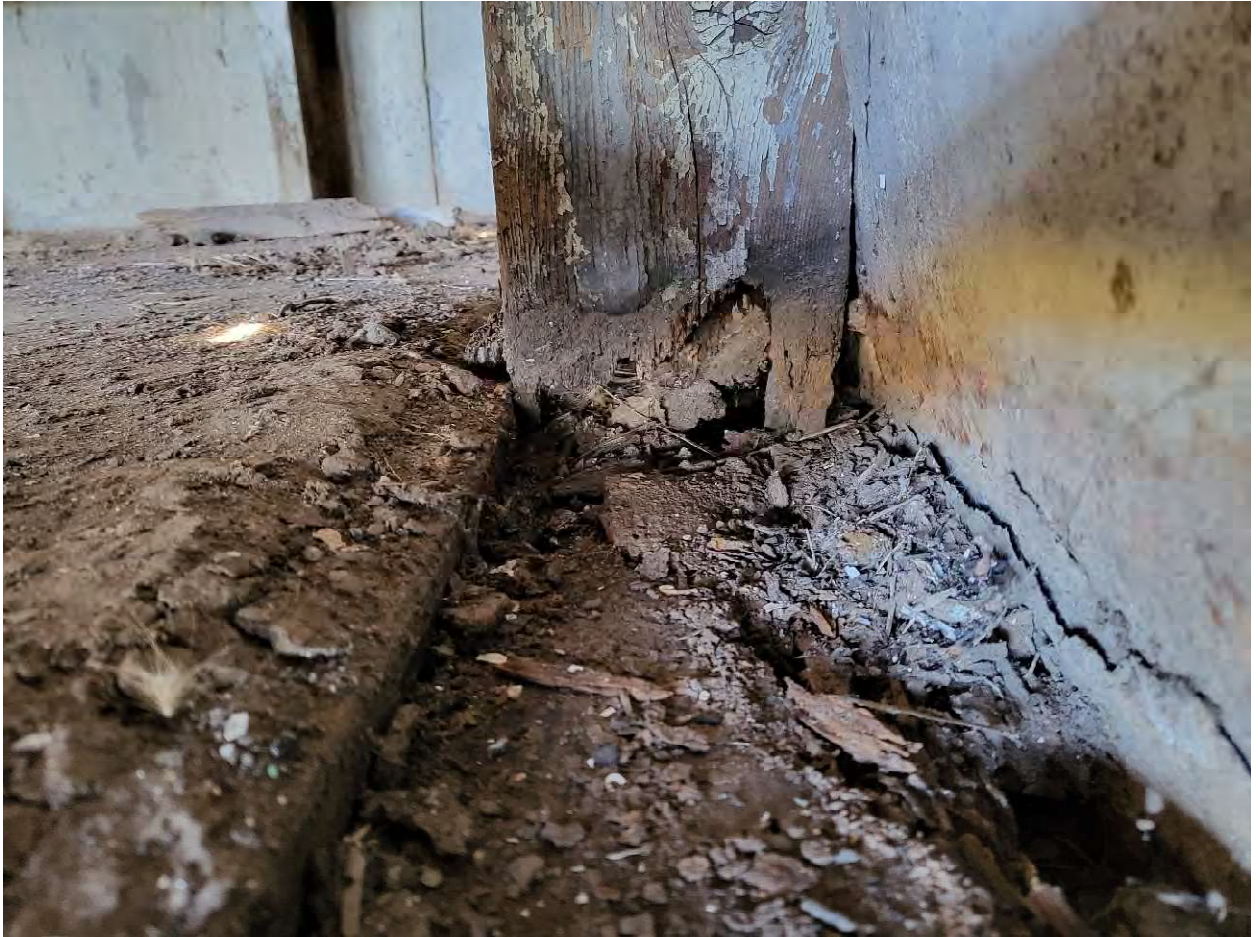
BUILDING 248 – DETERIORATION AT LOWER PORTION OF STUD WALL

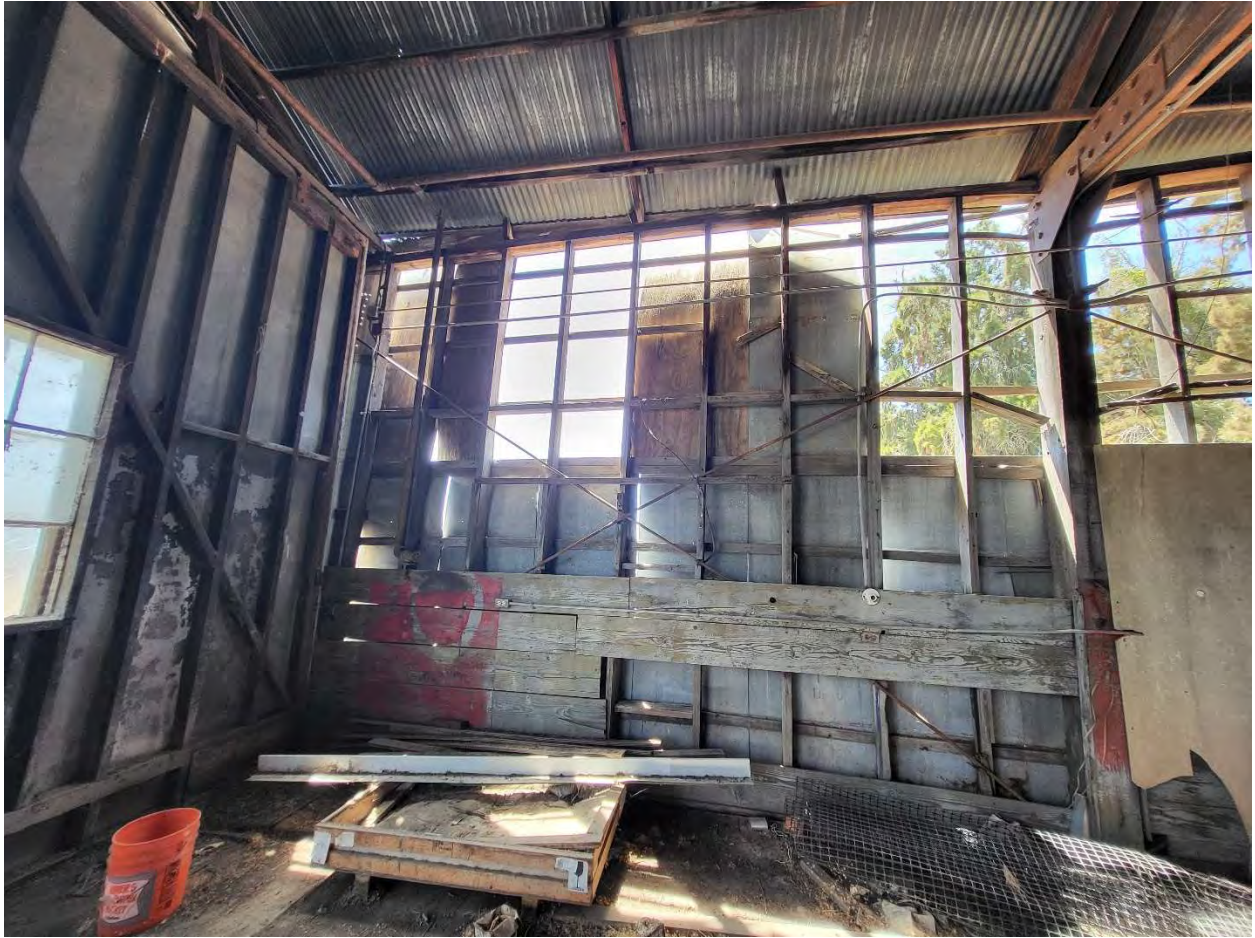
BUILDING 248 – WALL CLADDING FAILURE

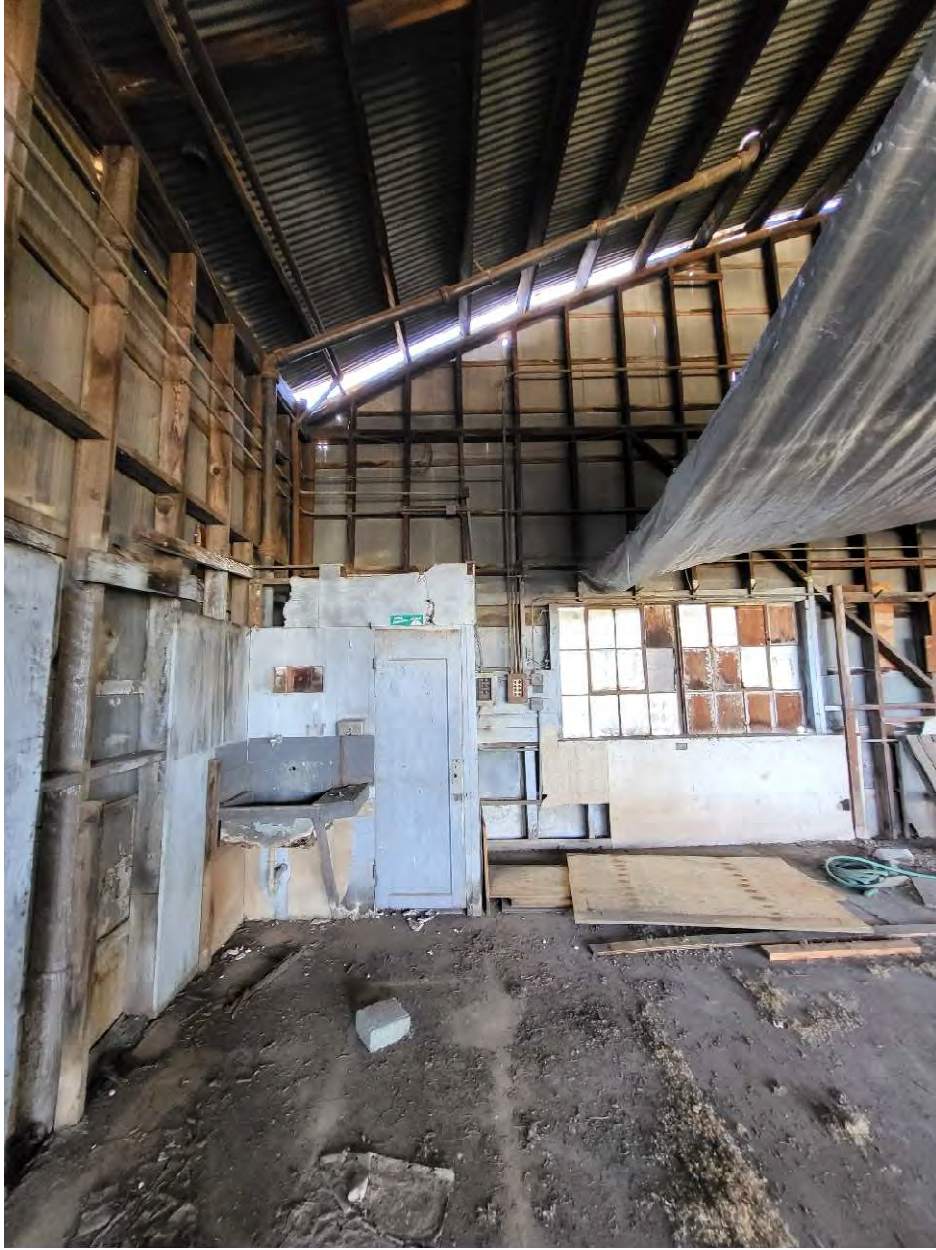
In 2022 Praxis Engineering observed that Building 248 is in poor structural condition. It sits on a downward slope within the San Pedro Creek floodway, and the exterior walls are subject to water exposure. The current finished floor height is below the existing Base Flood Elevation (BFE), resulting in deterioration at the base of the walls and sill plates. The southwest section of the roof has failed along the 80-foot wood trusses. The west side of the roof is damaged from deflection (Praxis Engineering 2022:4).

BUILDING 248 – ROOF CONNECTION DISPLACEMENT

All roof rafters, walls, metal sheathing, and associated connections will need to be removed and either reinstalled following repair or replaced following the reset of the trusses. A reset is required as the two primary roof trusses can no longer support the applied loads. For stability of the trusses, additional members should be sistered on or vertical supports should be added (Praxis Engineering 2022:4).

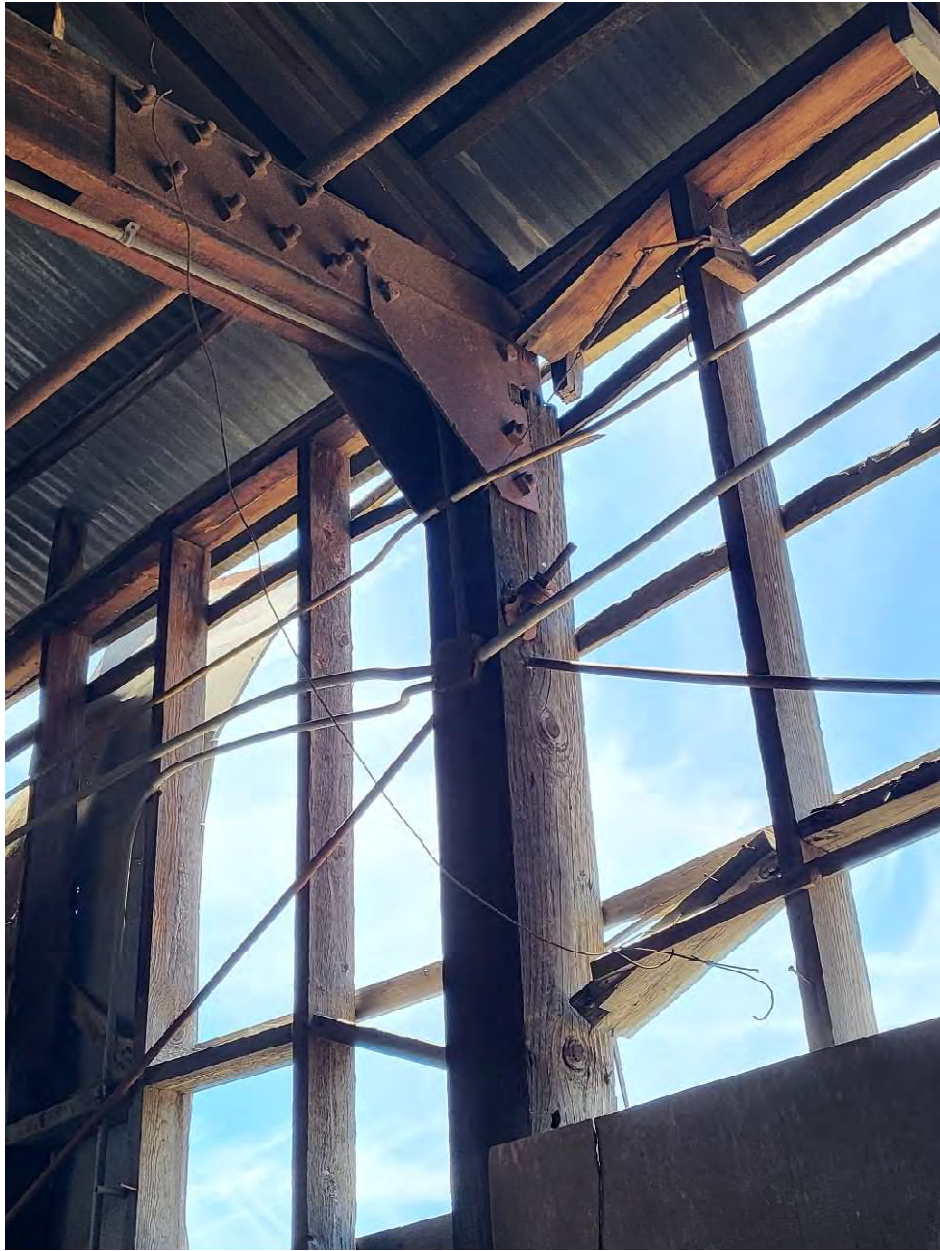
BUILDING 248 – BOWSTRING TRUSS WESTERLY CONNECTION 1

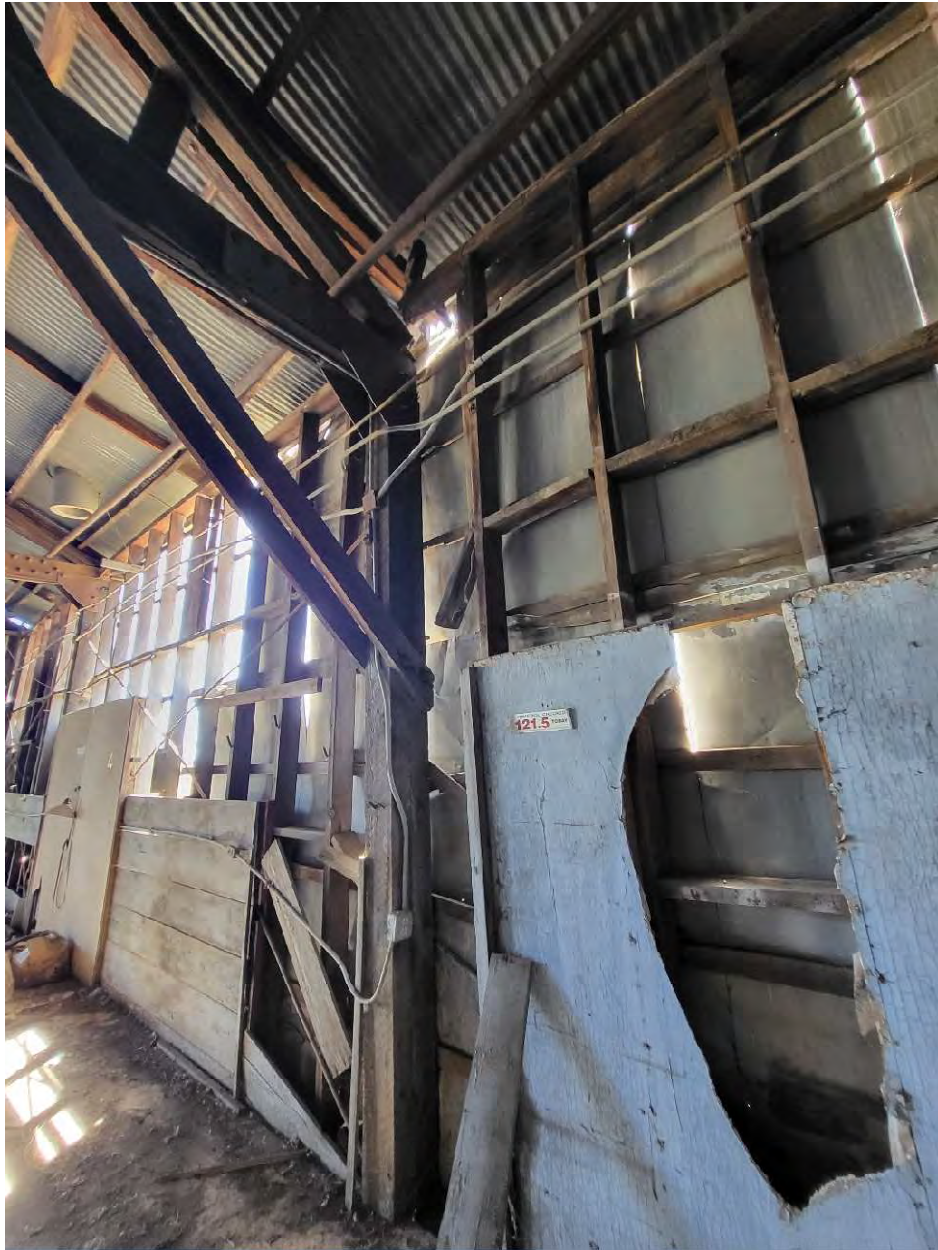
BUILDING 248 – BOWSTRING TRUSS WESTERLY CONNECTION 2

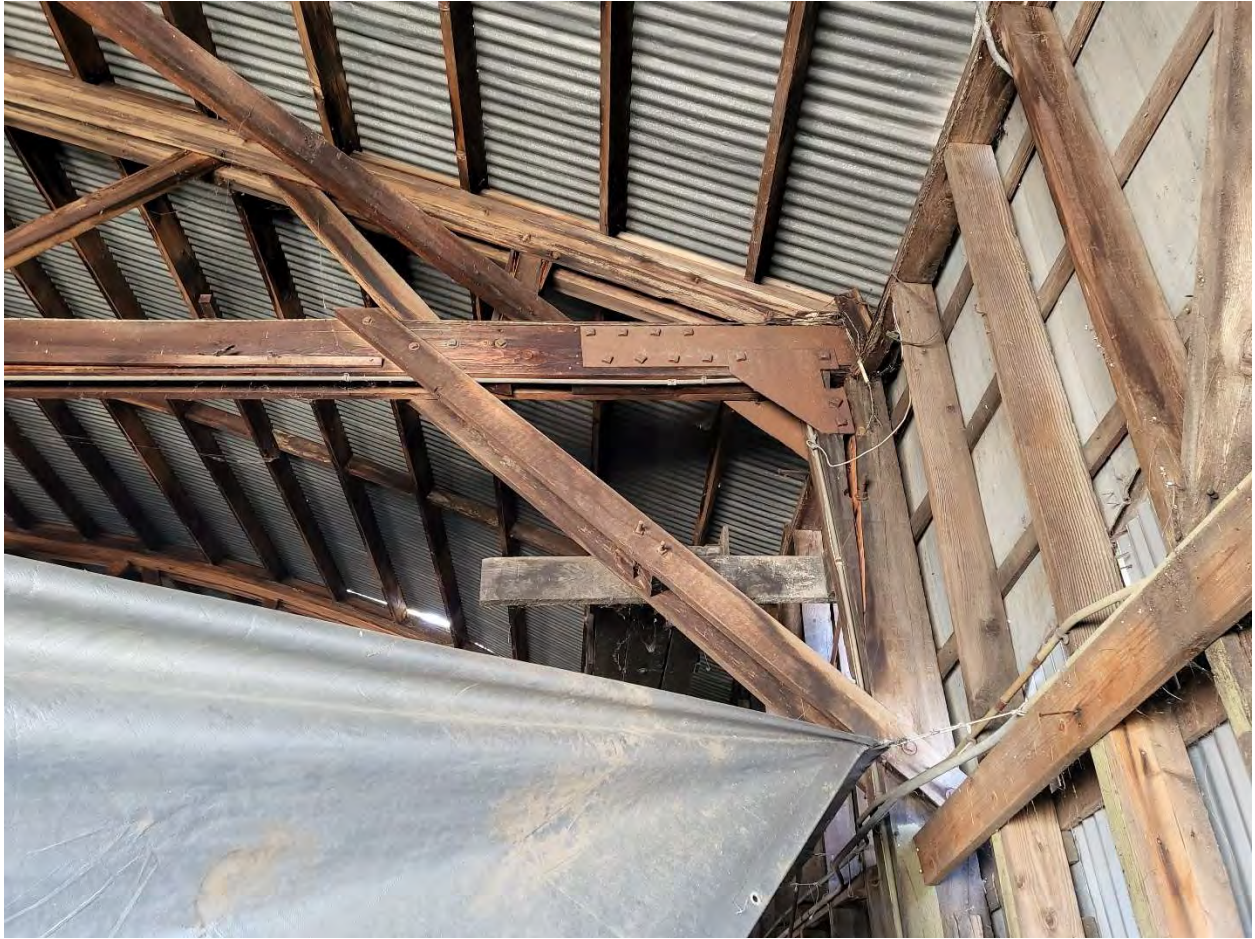
A portion of one truss and its support column have failed. All roof rafters, walls, metal sheathing, and associated connections will need to be removed and either reinstalled following repair or replaced following the reset of the trusses and their supporting column. A reset is required as the two primary roof trusses can no longer support the applied loads. Additional structural members should be sistered onto the trusses or vertical supports added for stability (Praxis Engineering 2022:7).

BUILDING 249 – TRUSS CONNECTION FAILURE
