# Appendix A: Pipe Conditions Assessment

## SBA Master Drainage Plan

SBA Master Drainage Plan  
04.04.2023 to 04.26.2024

## CCTV Inspections

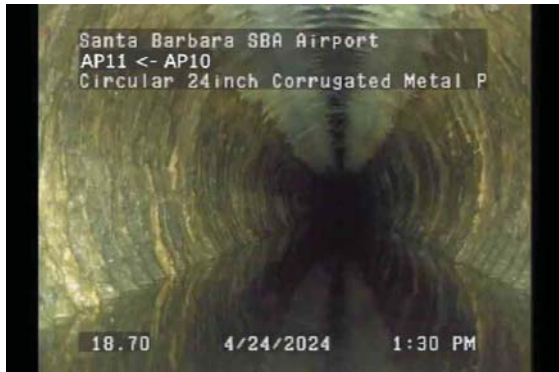
**18.70ft**  
**Surface Damage Corrosion from 2 o'clock to 5 o'clock, Start**

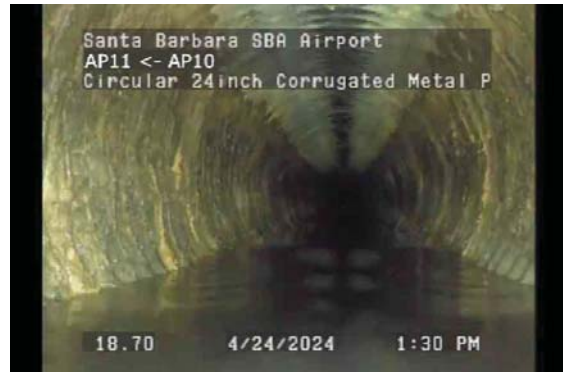
**18.70ft**  
**Surface Damage Corrosion from 7 o'clock to 10 o'clock, Start**

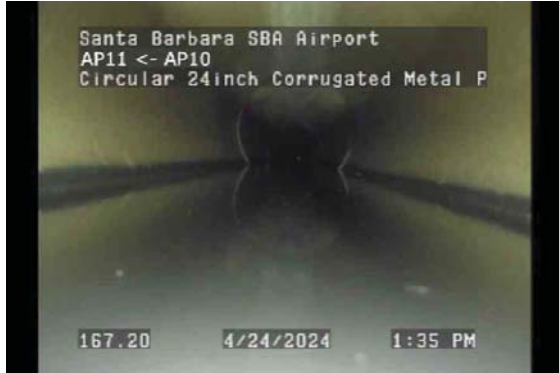
**167.20ft**  
Surface Damage Corrosion from 2 o'clock to 5 o'clock, Finish

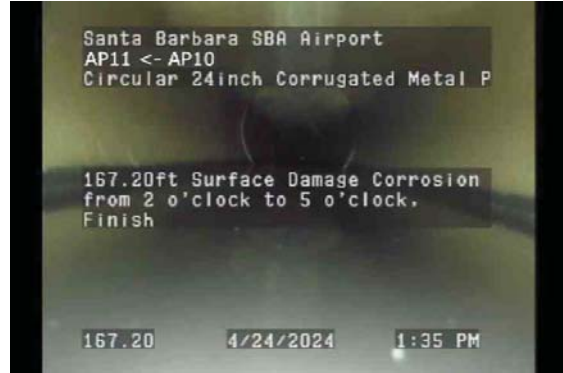
**167.20ft**  
Surface Damage Corrosion from 7 o'clock to 10 o'clock, Finish

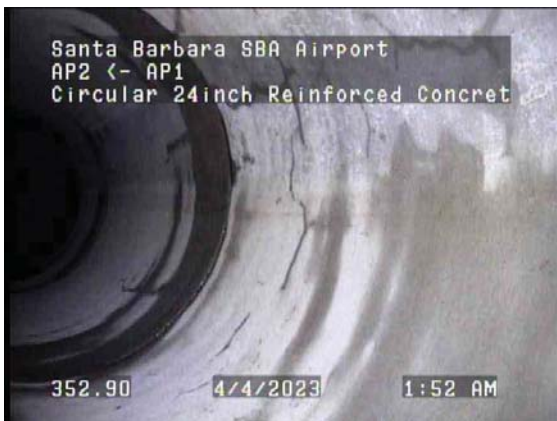
**352.90ft**  
Crack Multiple from 11 o'clock to 1 o'clock, within 8 inch

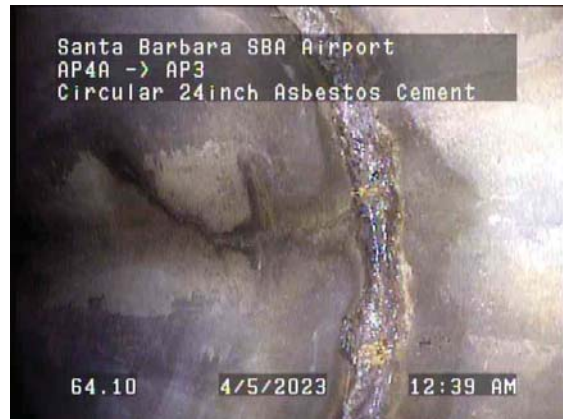
**64.10ft**  
**Crack Multiple from 11 o'clock to 1 o'clock, within 8 inch**

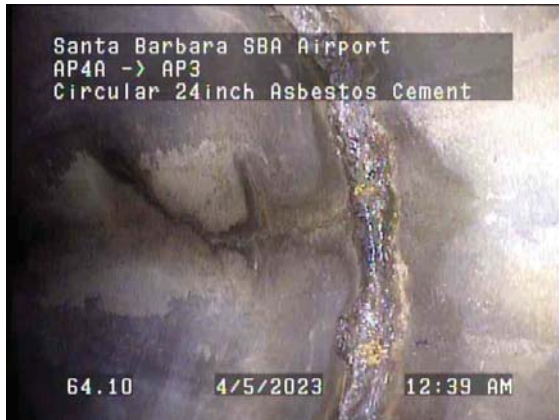
**64.10ft**  
Infiltration Dripper at 12 o'clock, within 8 inch

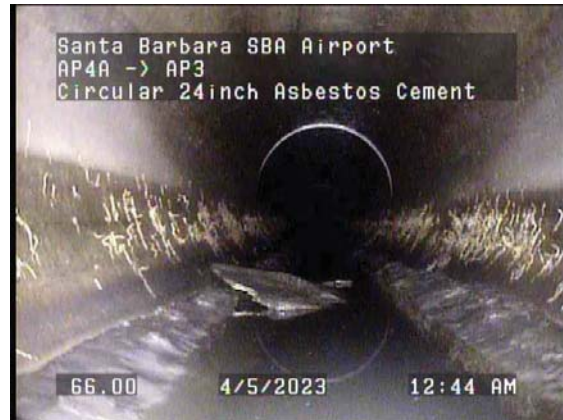
**66.00ft**  
Deposits Settled Other, 5% of cross sectional area from 6 o'clock to 7 o'clock / Debris

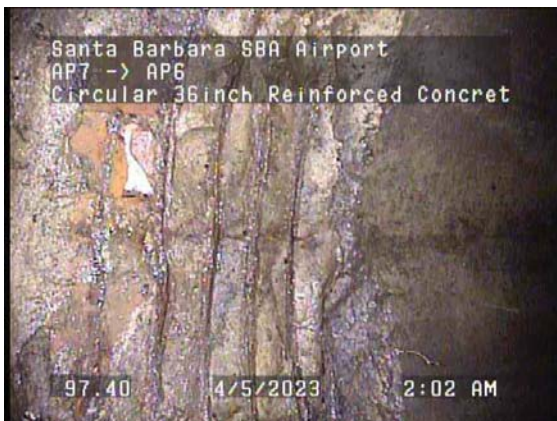
**97.40ft**  
**Surface Damage Reinforcement Visible**  
**from 11 o'clock to 1 o'clock, within 8 inch**

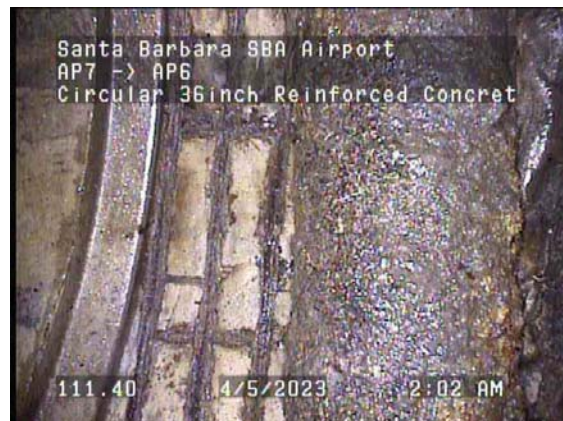
**111.40ft**  
**Surface Damage Reinforcement Visible**  
**from 11 o'clock to 1 o'clock, within 8 inch**

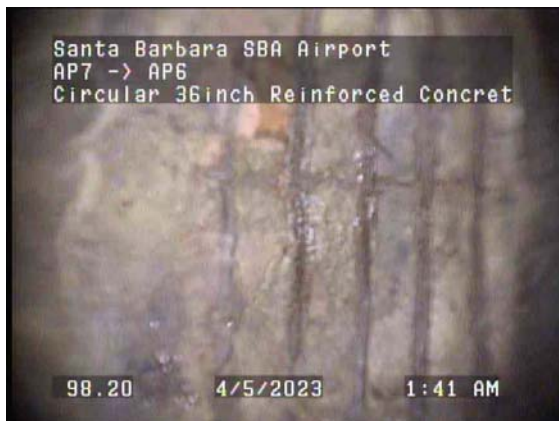
**98.20ft**  
**Surface Damage Reinforcement Visible from 11 o'clock to 1 o'clock**

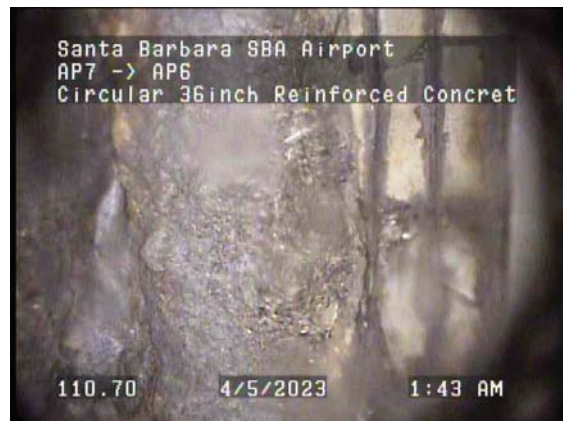
**110.70ft**  
**Intruding Sealing Material Grout, 10% of cross sectional area from 11 o'clock to 1 o'clock**

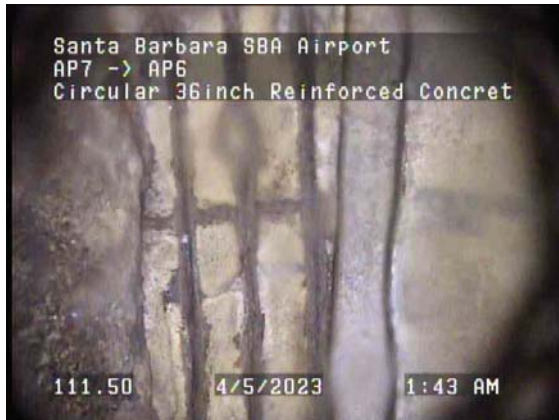
**111.50ft**  
**Surface Damage Reinforcement Visible**  
**from 11 o'clock to 1 o'clock, within 8 inch**

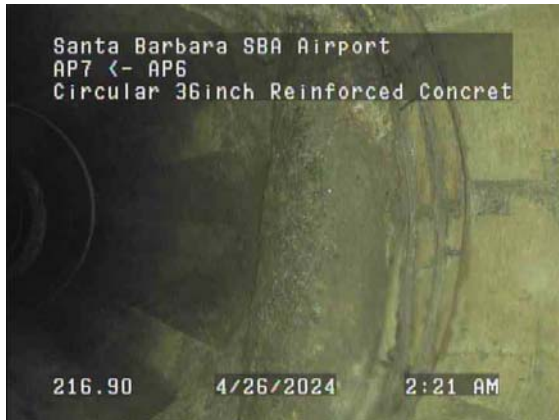
**216.90ft**  
**Surface Damage Reinforcement Visible**  
**from 11 o'clock to 1 o'clock, within 8 inch**

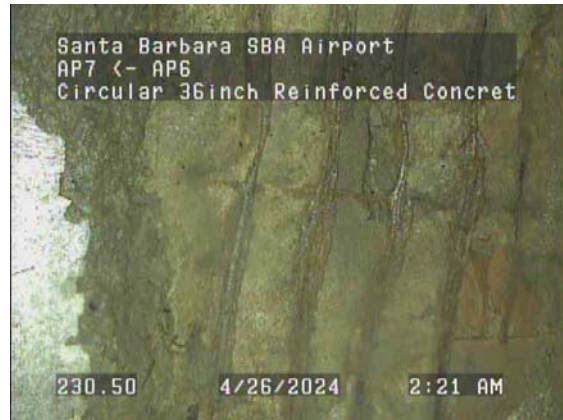
**230.50ft**  
**Surface Damage Reinforcement Visible**  
**from 11 o'clock to 1 o'clock, within 8 inch**

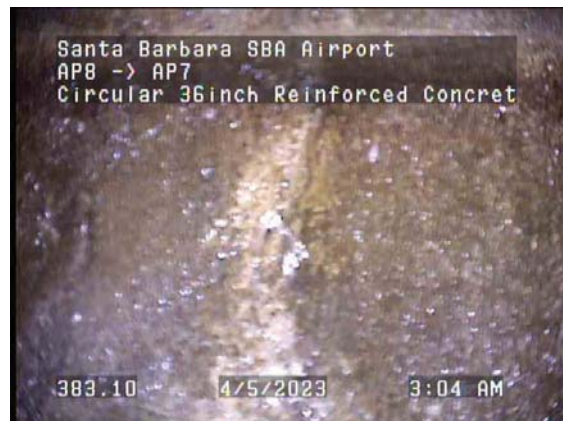
**383.10ft**  
**Infiltration Runner at 4 o'clock, within 8 inch**

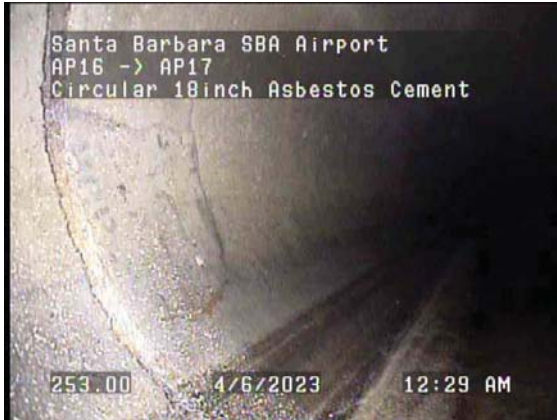
**253.00ft**  
Crack Multiple from 7 o'clock to 9 o'clock, within 8 inch

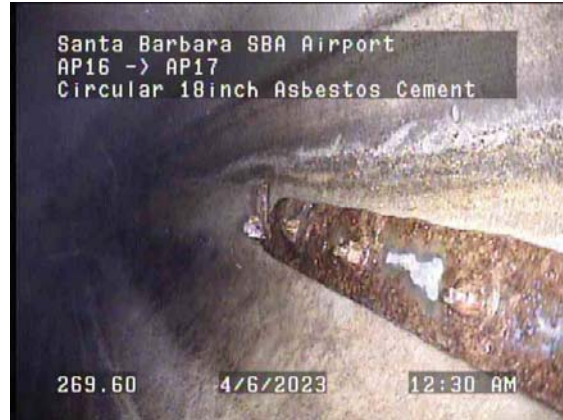
**269.60ft**  
Deposits Settled Other, 5% of cross sectional area from 4 o'clock to 5 o'clock / metal

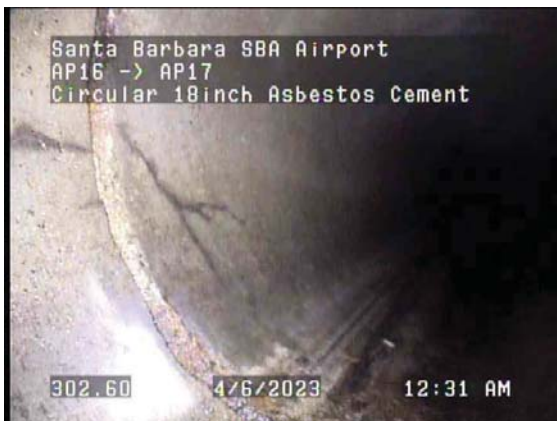
**302.60ft**  
Crack Multiple from 8 o'clock to 9 o'clock, within 8 inch

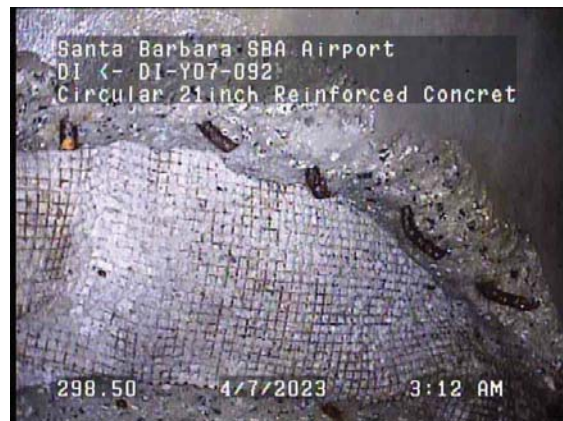
**298.50ft**  
**Surface Damage Reinforcement Visible from 9 o'clock to 10 o'clock**

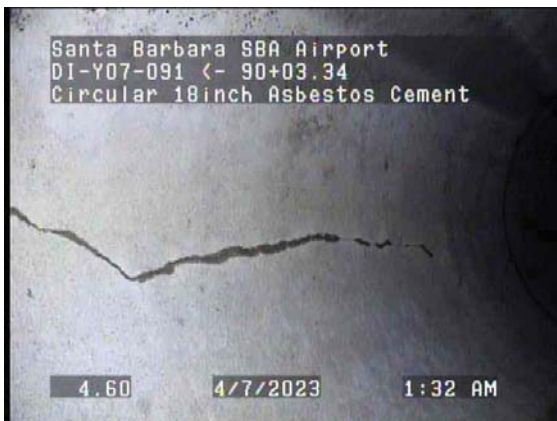
**4.60ft**  
**Crack Longitudinal at 10 o'clock**

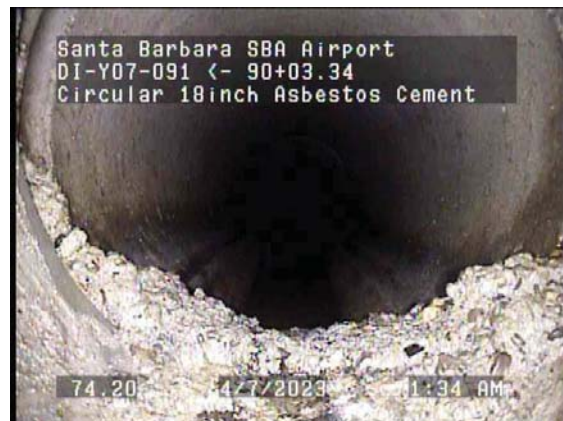
**74.20ft**  
**Intruding Sealing Material Grout, 10% of cross sectional area from 4 o'clock to 8 o'clock**

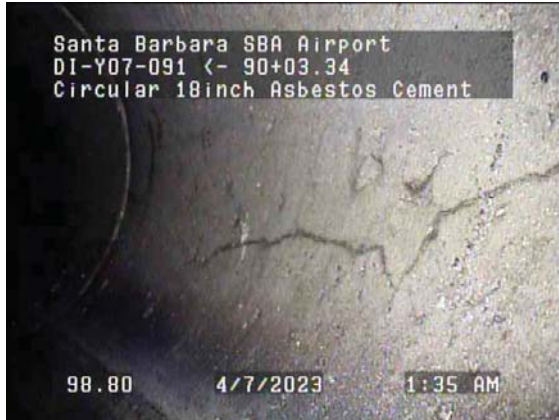
**98.80ft**  
Crack Multiple from 3 o'clock to 4 o'clock

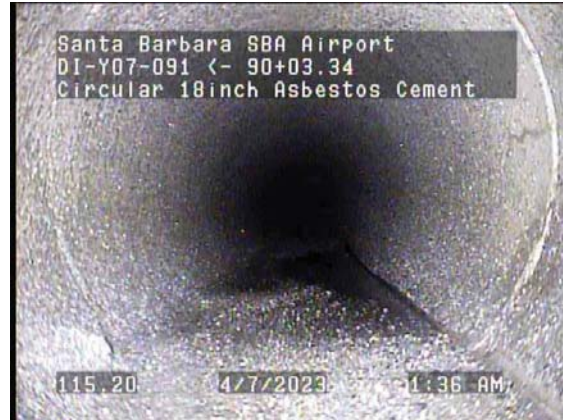
**115.20ft**  
Deposits Settled Other, 5% of cross sectional area from 5 o'clock to 7 o'clock, Start / Debris

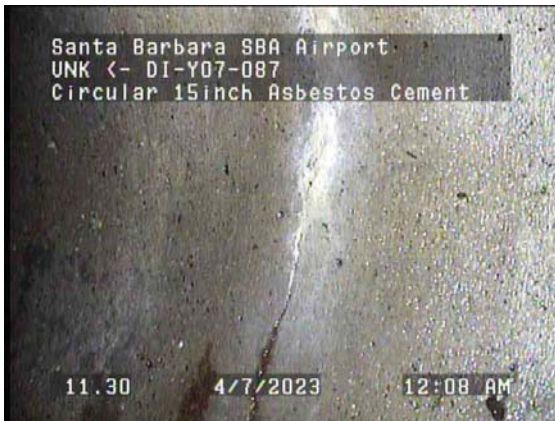
**11.30ft**  
**Crack Circumferential from 7 o'clock to 5 o'clock**

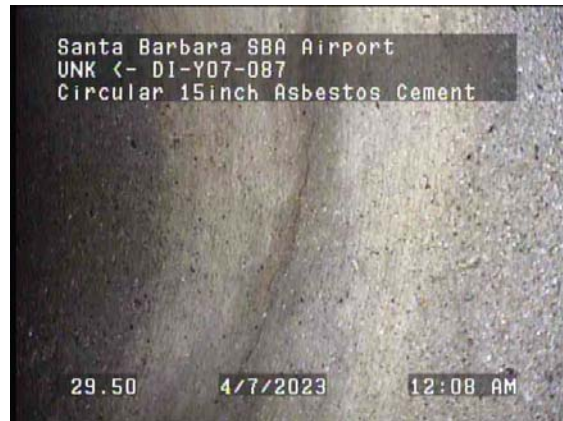
**29.50ft**  
**Crack Circumferential from 7 o'clock to 5 o'clock**
