SANTA BARBARA AIRPORT City of Santa Barbara

Location: Santa Barbara Airport, Goleta, California

> > June 13, 2002

Conditions and Further Use Analysis Study for Airport Hanger Buildings No. 248 & 249.

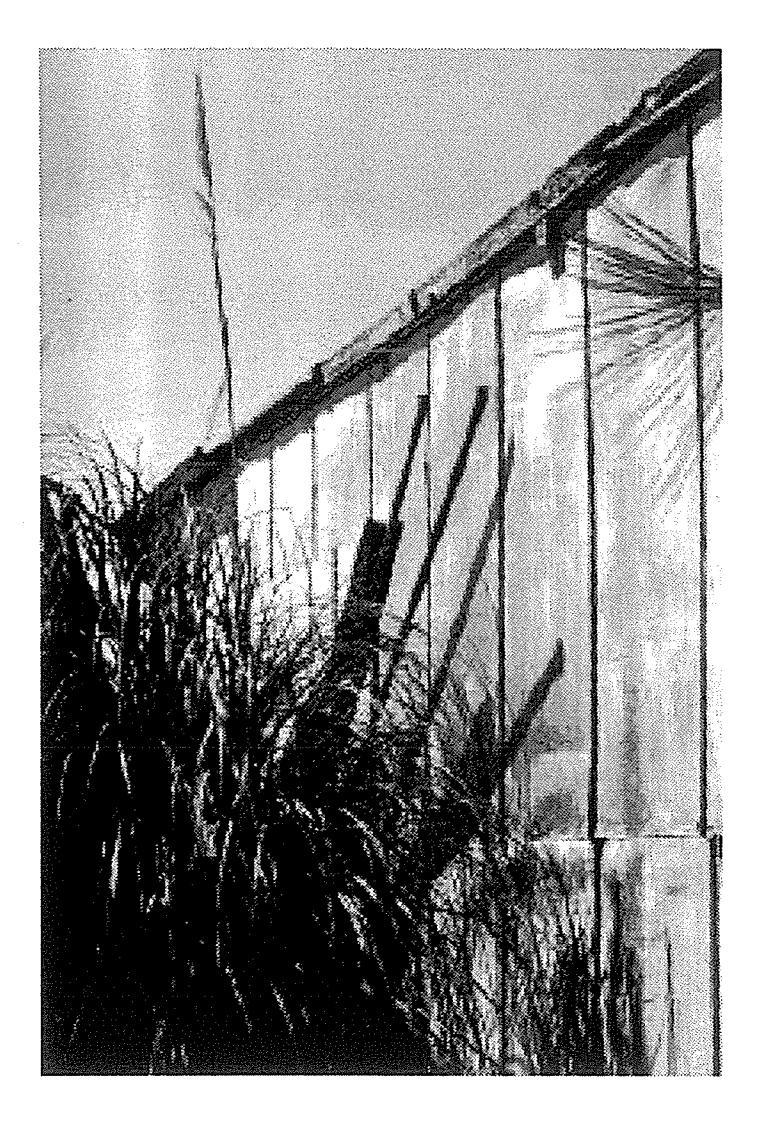
Toward the front of the west elevation, a thick clump of bamboo has taken root very near the hangar. The plant may be causing damage to the hangar. The timber gutter has broken off, with only a small length toward the front remaining in place. A long length of wood gutter has fallen and is protruding from the bamboo plant. (See Figure 15.) The small section of gutter that

Figure 15. The timber gutter on the east elevation of Hangar 249 has broken off, with only a small length toward the front remaining in place. A long length of wood gutter has fallen and is protruding from the bamboo plant.

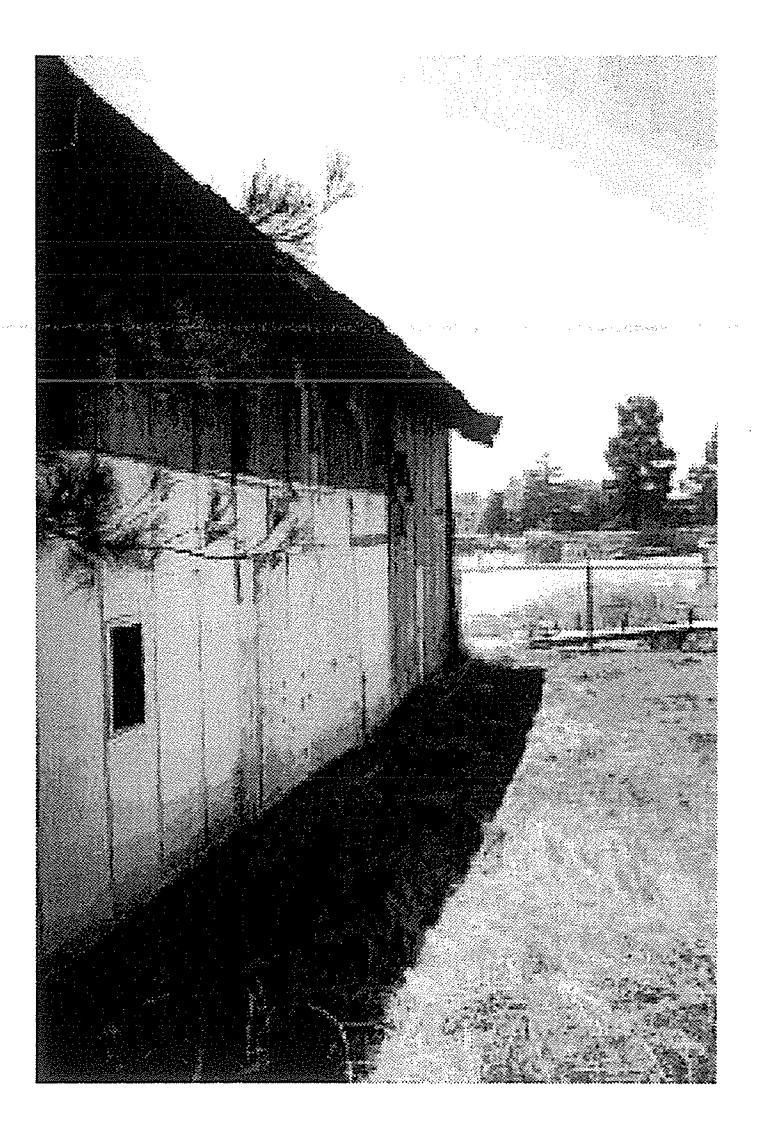
The metal panels forming the center section of the west elevation were removed for an addition. The addition was later demolished and the center section has been replaced with wood panels, which are buckling out at the center. (*See Figure 14.*) The rest of the siding is comprised of standing-seam metal panels; all are bare metal, with the exception of those at the lower rear corner which are painted white. There is one door opening and two window openings, both of which were cut into the metal panels. The wood panels are marred by protruding nails. The wood is not deteriorating but is in need of paint. As opposed to all other elevations of both hangars, the concrete slab on this side extends 24 inches from the building. Wires, which seem to be obsolete, hang from the top of this side. In general, this elevation is heavily modified and sloppily constructed.

Figure 14. The replacement wood panels that form the center section of the west elevation are buckling out at the center.

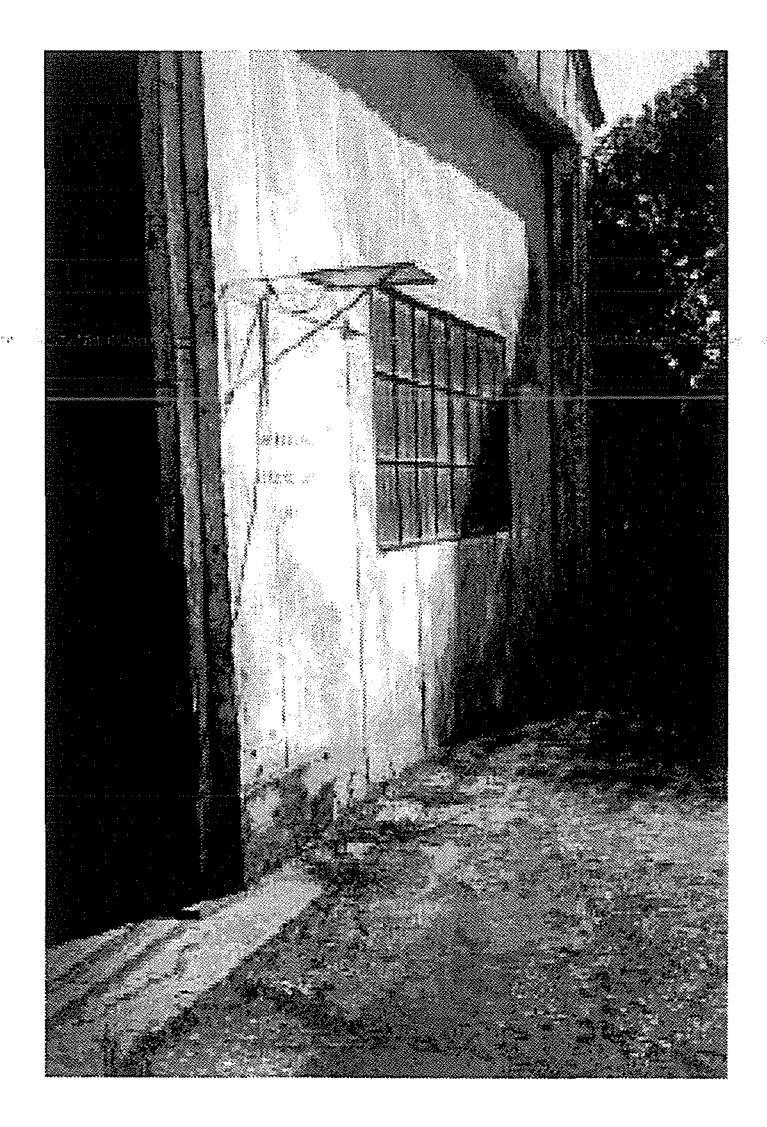
Each of the four aircraft doors is punctured by a window opening that holds two side-by-side 4over-3 fixed-pane, steel-framed windows. (See Figure 6.) All panes are wired safety glass and appear to be original with the exception of twelve panes of clear replacement glass in the outside door on the west side. The outside door on the west side has also been altered to accommodate a divided sheet metal door for pedestrians at the far west side of the main elevation; the door does not extend to ground level so that one has to step over the lower part of the wall and into the interior. Iron plates are bolted to the doors' bottom corners to house the rollers and to protect the lower door corners from damage.

Figure 6. Each of the four aircraft doors is punctured by a window opening that holds two side-by-side 4-over-3 fixed-pane, steel-framed windows.

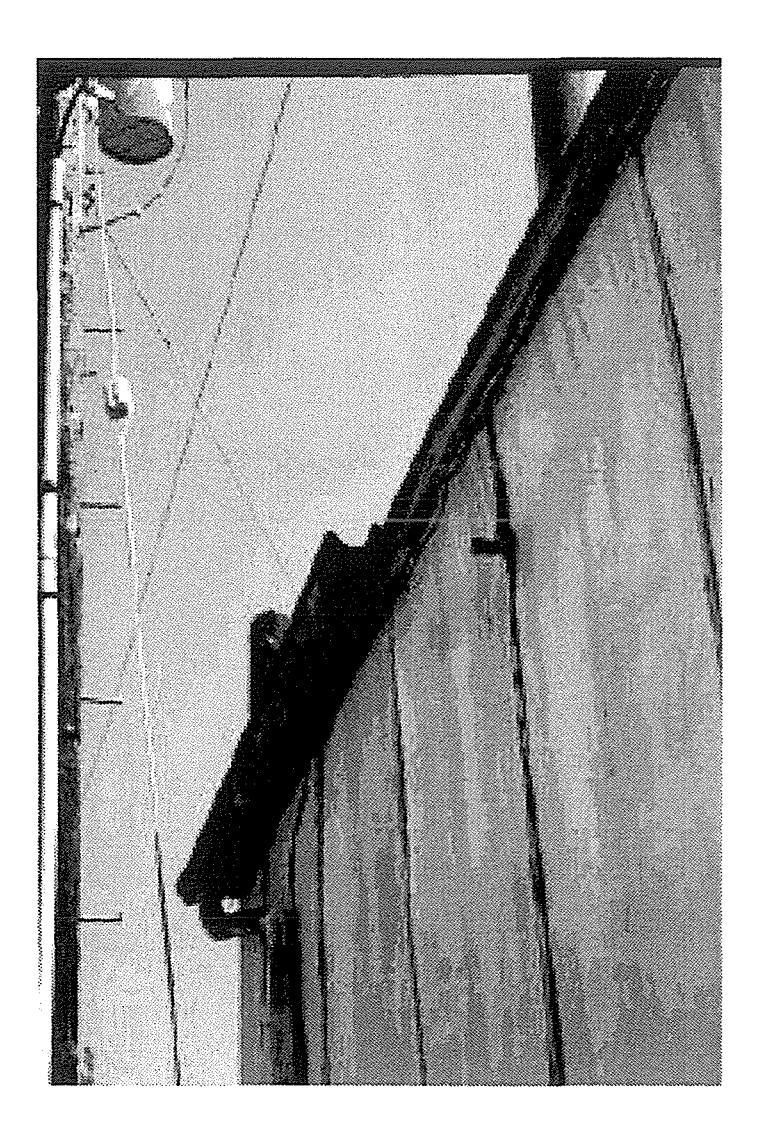
The timber gutter has broken off and, for the most part, is missing, with the exception of a small section toward the rear of the elevation that remains in place and is attached to a corroded metal downspout. (See Figure 8.) A water pipe connection is in place at the northwest corner.

Figure 8. The timber gutter has broken off and, for the most part, is missing, with the exception of a small section toward the rear of the elevation that remains in place and is attached to a corroded metal downspout.

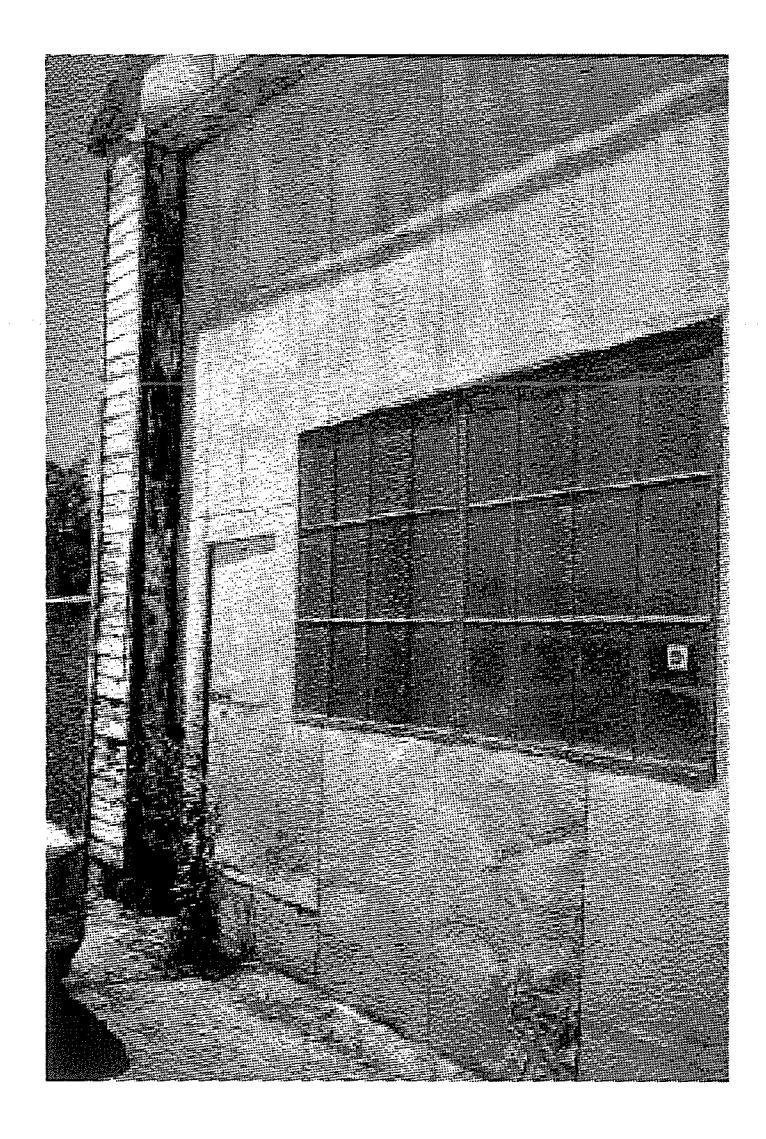
Figure 12. Smaller doors cut have been cut into two of the large sliding doors of Hangar 249 for pedestrian access. These access doors are located to the left of center and at the far right of the main facade.

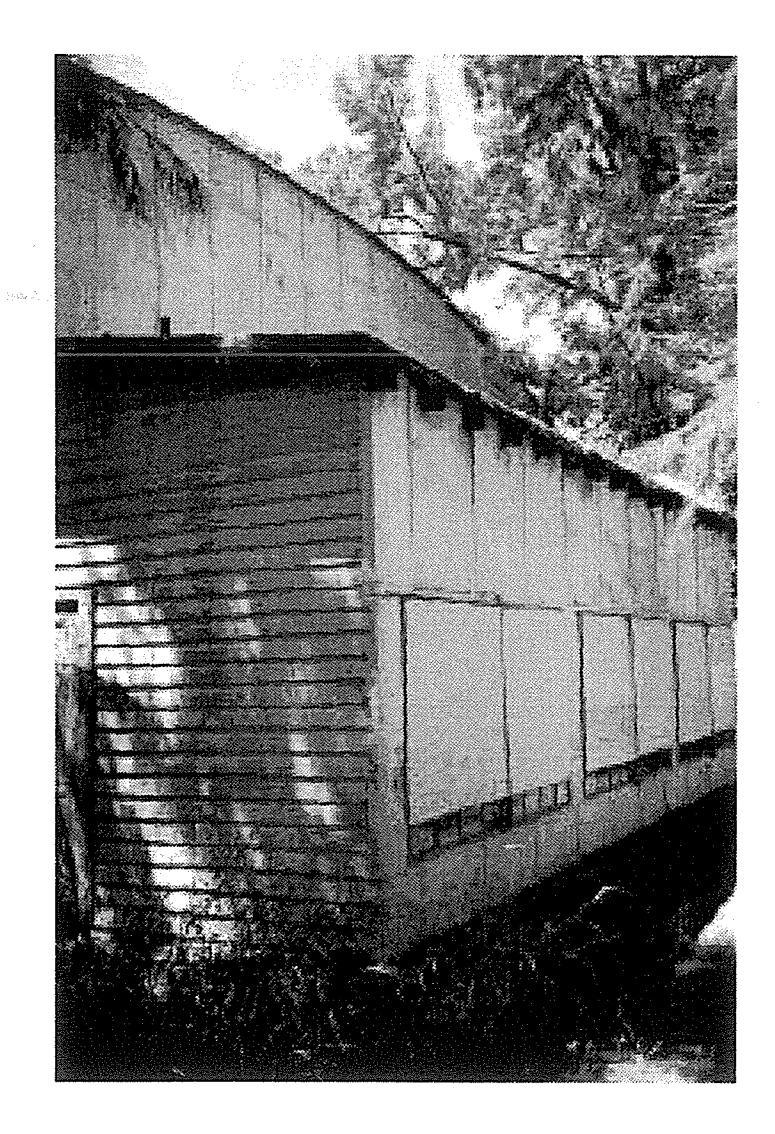
Figure 13. At the rear of Hangar 249, the original band of windows and salvaged sheet metal panels were reused to form the north wall of the addition.
