SANTA BARBARA AIRPORT City of Santa Barbara

Location: Santa Barbara Airport, Goleta, California

> > June 13, 2002

Conditions and Further Use Analysis Study for Airport Hanger Buildings No. 248 & 249.

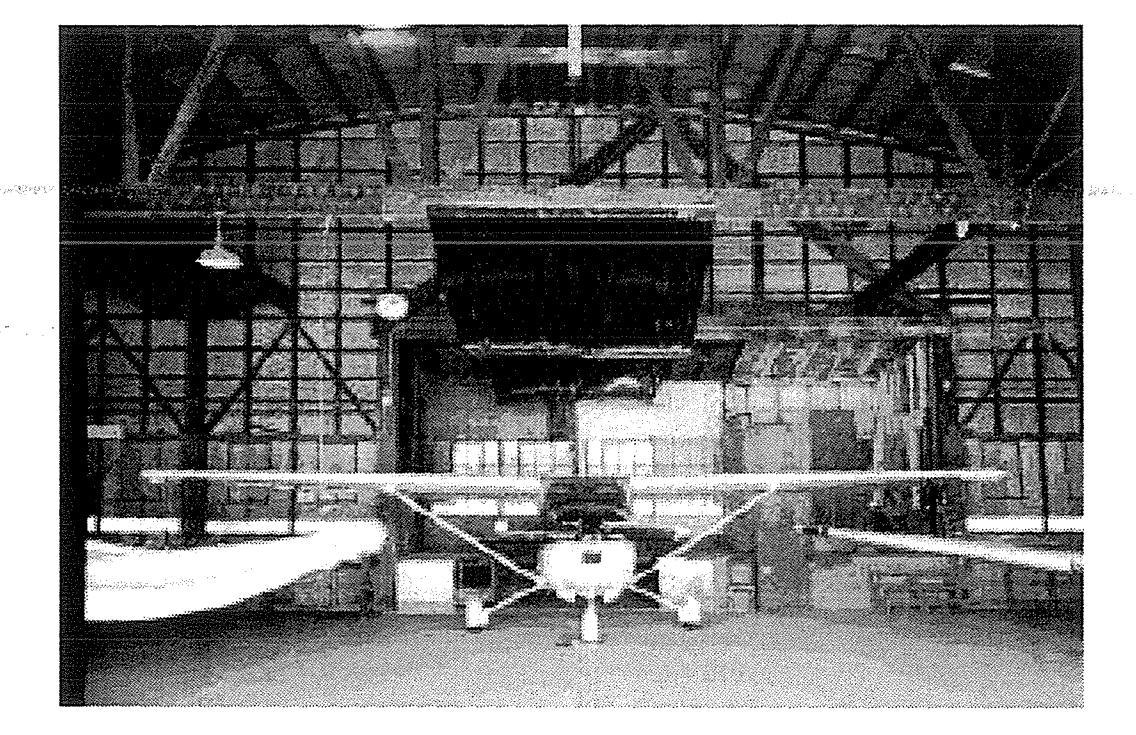
The principal construction of the hangar buildings is timber frame with a king-post redwood truss system allowing a wide interior span without supporting columns. (See Figure 2.) The hangars rest on a poured-in-place concrete slab. The exteriors are clad in standing-seam sheet metal panels, painted white, that generally measure 36 inches wide (including seam) and 96 inches long and wrap the corners. The roof's barrel vault shape is sheathed in corrugated sheet metal. Interior walls are made up of a light framing system of exposed timber. Iron truss clips and square-headed bolts secure the trusses. (See Figure 3.) The materials and construction

Figure 2. The principal construction of the hangar buildings is timber frame with a king-post redwood truss system allowing a wide interior span without supporting columns.

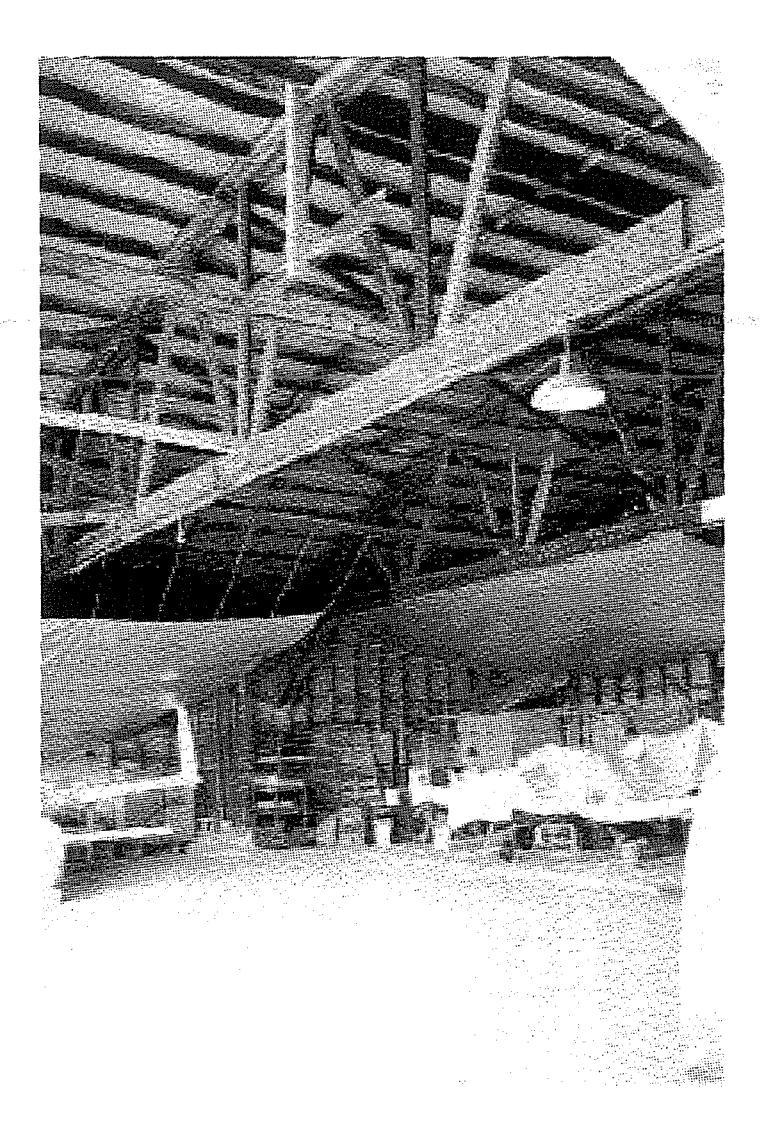
Figure 3. Interior walls are made up of a light framing system of exposed timber and iron truss clips and square-headed bolts secure the trusses.

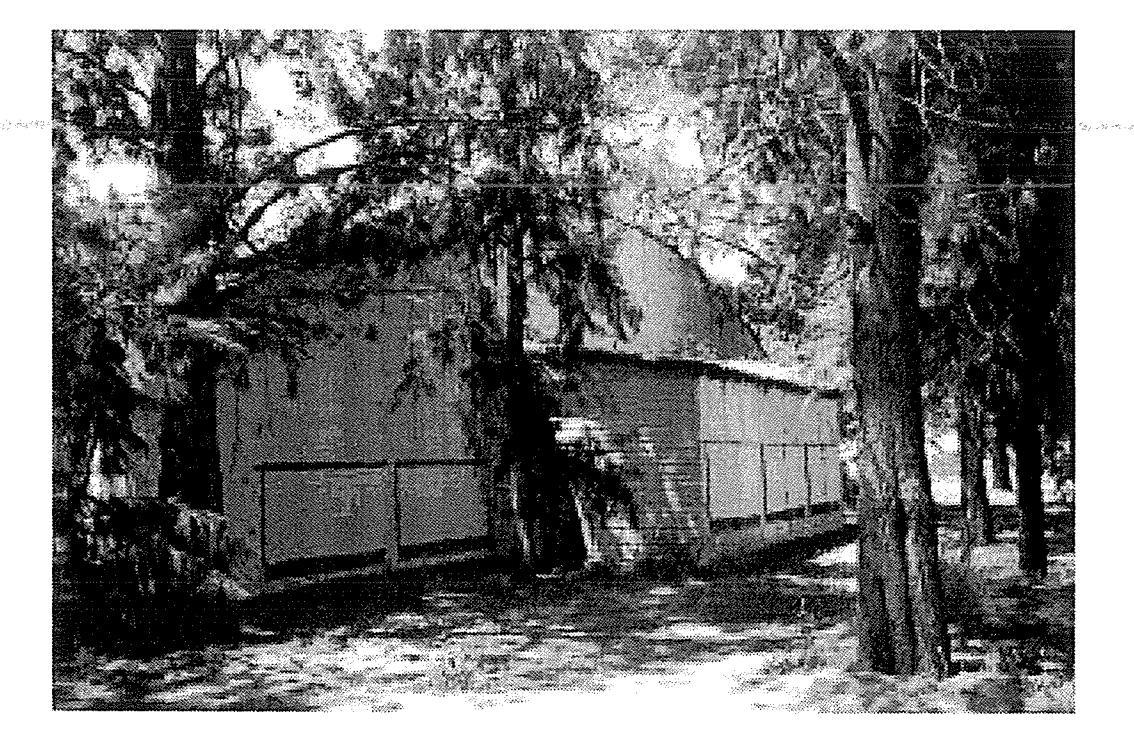
Both hangars measure approximately 60 by 80 feet, forming regular rectangular plans. Over time both hangars expanded and were modified to include additions which were later removed, returning the buildings to their approximate original rectangular footprints. The exception is the one-story shed-roofed expansion at the rear of Building 249 which remains in place. (See Figure 4.)

Figure 4. Hangar 249 was modified to add a one-story shed-roofed expansion at the rear.

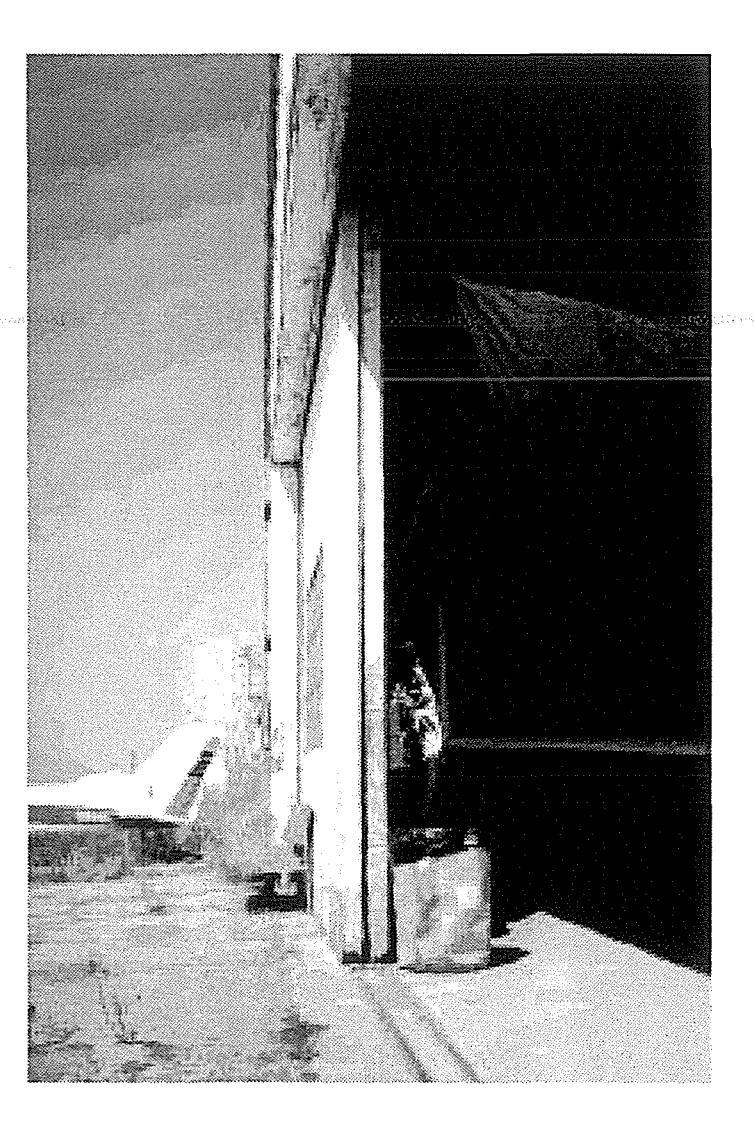
The principal elevation of Building 248 is defined by a low shallow arch and is comprised of two pair of sliding aircraft doors, two on an inside track and two on an outside track. (See Figure 5.) The sliding hangar doors are clad in flush-seam galvanized sheet metal and measure 15 feet high. Above the doors, an arched expanse of wall is clad with standing-seam panels. As aircraft doors, they were originally designed so that when closed they formed a solid wall and when pushed open they allowed maximum clearance. Presently the aircraft doors of Building 248 have been welded to remain open and inverted "V" metal brackets have been welded to the tracks to block movement. The doors span nearly the entire width of the facade with narrow wall space at either end of the door opening. The wall space is comprised of short boards, horizontally laid and painted white. All boards remain intact and are in fair condition; paint is peeling.

Figure 5. The principal elevation of Building 248 is comprised of two pair of sliding aircraft doors, two on an inside track and two on an outside track.

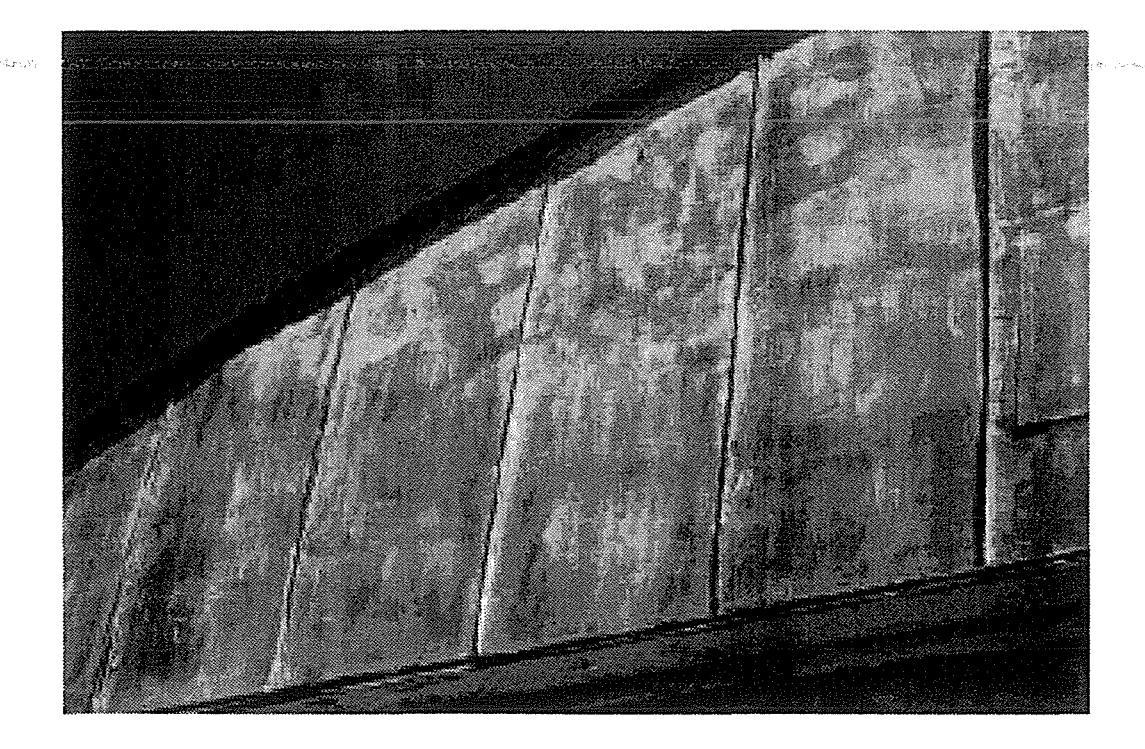
Figure 7. Below the curve of the arch, faded original lettering remains that reads "General Western Aero Corp Ltd."

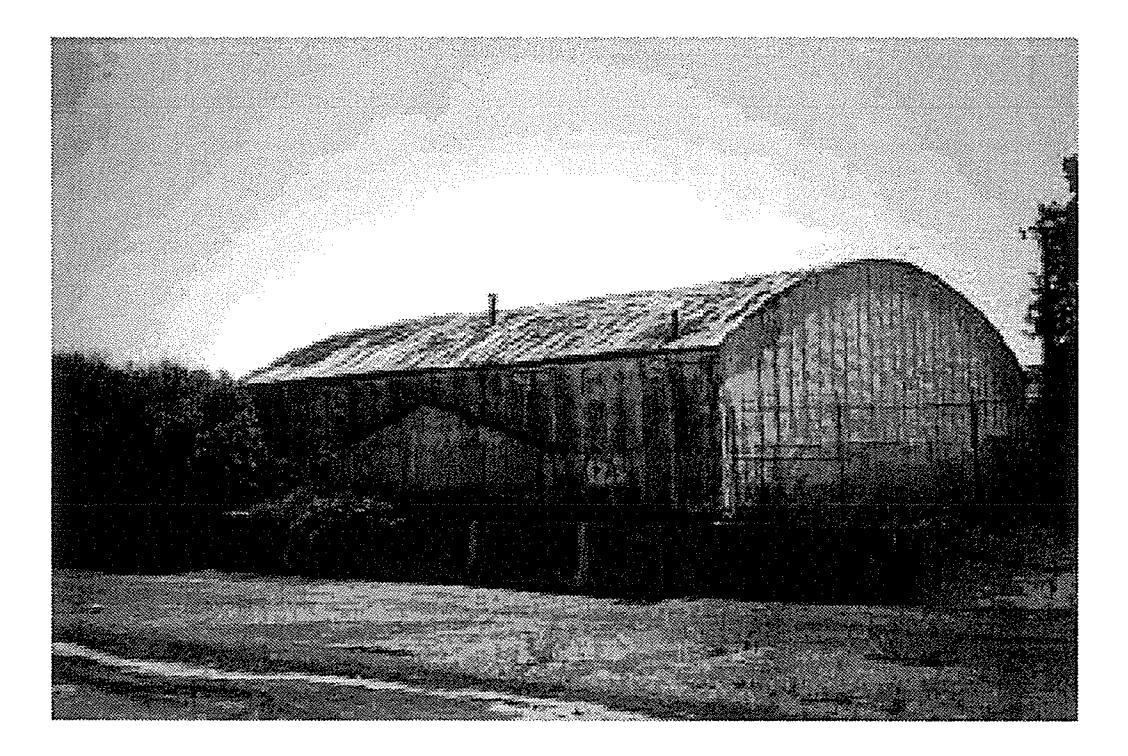
Because of overgrowth, fencing and the drop to the adjacent San Pedro channel, the east elevation is only visible from a distance across the channel. (See Figure 9.) Like the other elevations, the siding made up of sheet metal panels. Though the panels on the east side are in

poorer condition, rusted and covered in graffiti. The chain link fence stops at both corners of the east elevation, so that this side of the building is open to the channel.

Figure 9. The east elevation of Hangar 248 is only visible from a distance, across the San Pedro channel.

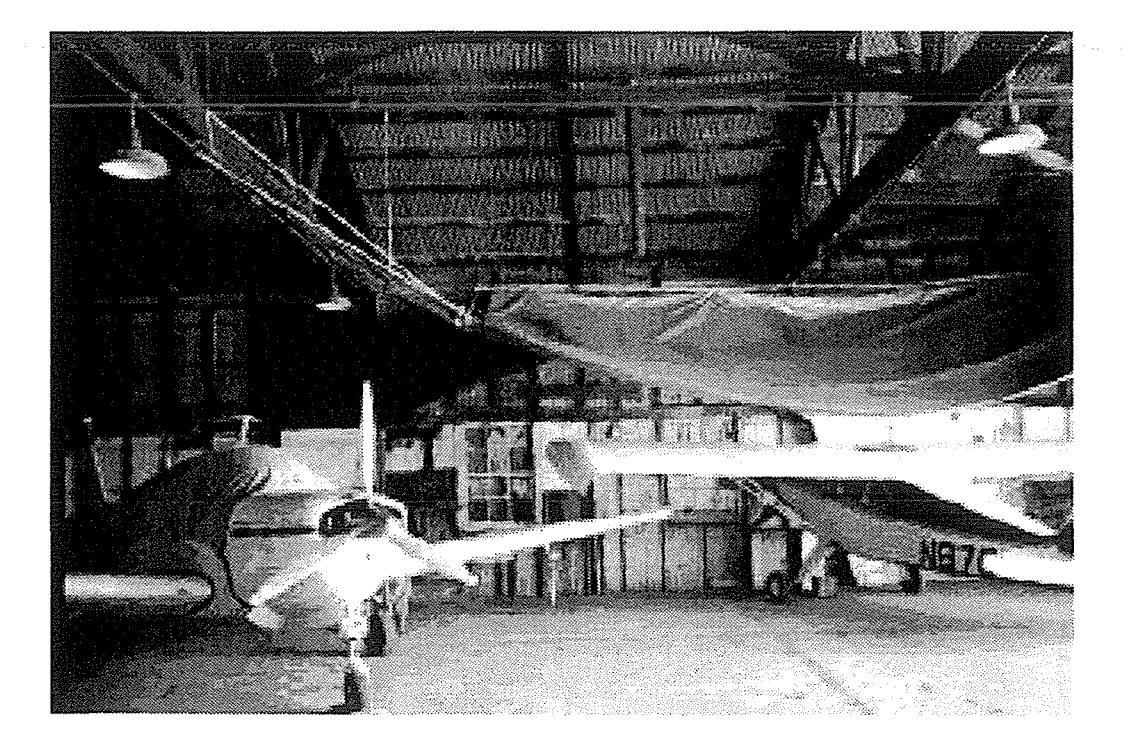
The poured-in-place concrete floor is in good condition with minimal evidence of cracking. Faded paint lines mark the floor. The most prominent and distinguishing features of the interior are the pair of segmental arch redwood trusses that span the width of the interior. *(See Figure 10.)* The trusses are held with iron truss clips and square-headed bolts. The redwood trusses appear to be sound with no sign of distortion or significant water infiltration. The interior walls are of exposed timber framing. Throughout the interior there are a number of replacement boards that have accrued over time though it is not clear if they serve any purpose. Behind the framing, walls are formed from the sheet metal cladding. To some extent seams have opened along all the walls. The contents of the hangar's interior reveal its function as a storage facility for owners of light aircraft. The building contains built-in cabinets, tools, equipment, work benches, boxes and plastic milk crates, and stepladders.

Figure 10. Typical features on the interior include poured-in-place concrete floor with faded painted lines and paired segmental arch redwood trusses that span the width of the space.

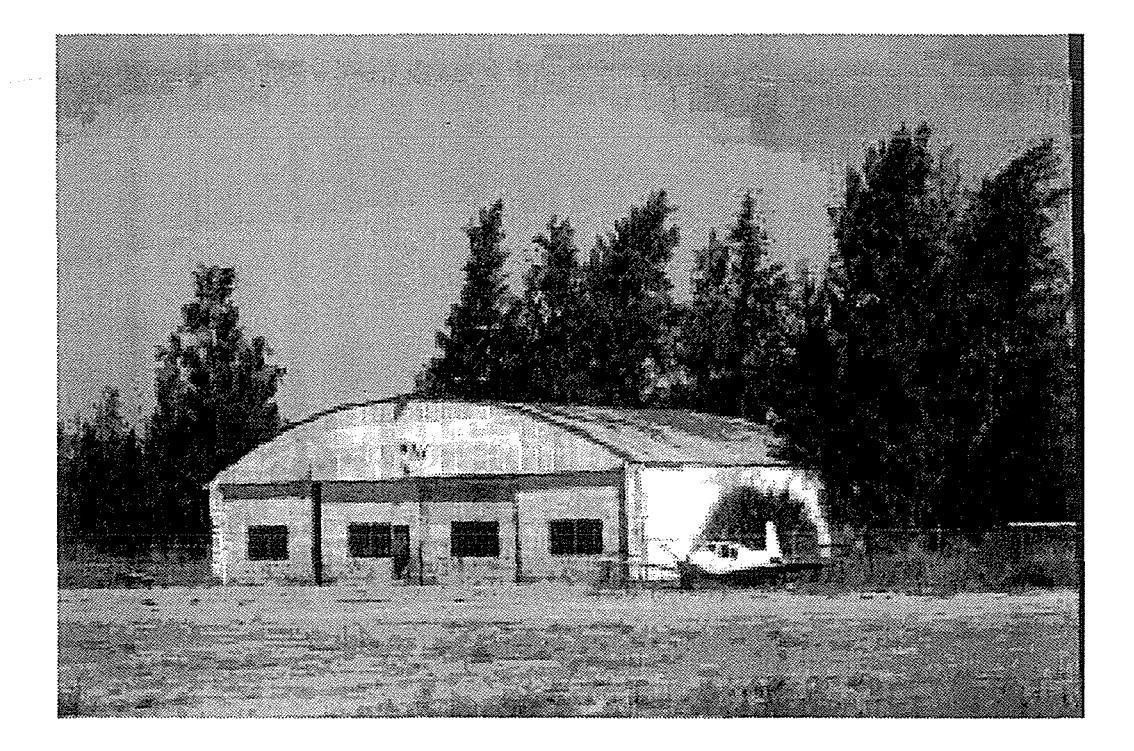
Building 249's principal elevation is defined by a low shallow arch and is comprised of two pair of sliding aircraft doors, two on an inside track and two on an outside track. (See Figure 11.) The

Figure 11. Building 249's principal elevation is defined by a low shallow arch and is comprised of two pair of sliding aircraft doors.
Architectural Resources Group

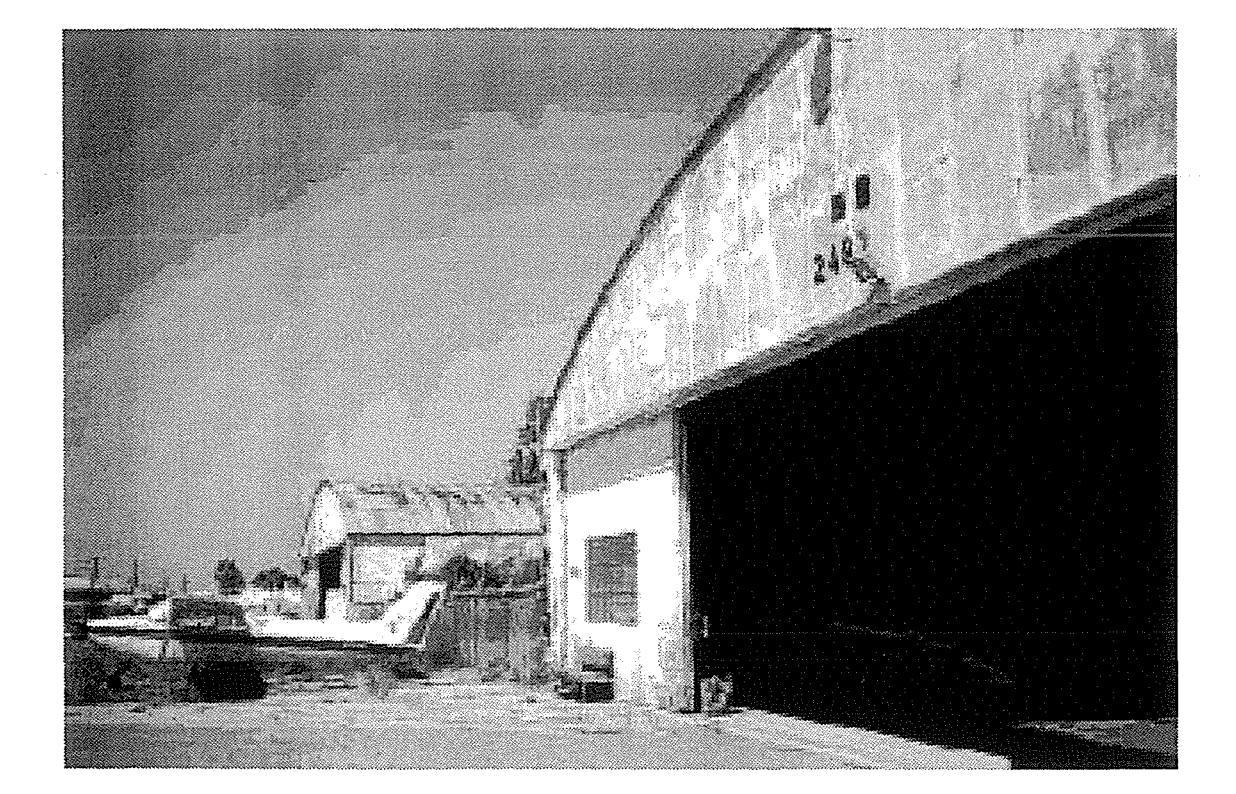
The hangars are located at the northeast corner of the Santa Barbara Municipal Airport and are spaced approximately 100 feet apart from each other on a downward sloping site that is located within a floodway. *(See Figure 1.)* The original airport Administration Building was previously sited between the two hangars. The site naturally slopes toward the south, toward the front of the hangars, but the height and angle of the grade have changed, becoming more built up over time. The resulting change in ground level appears to be attributable to the accumulation of dirt, pine needles, and other organic growth, and the detrimental residual effects of the floodway site.

Figure 1. Hangars 248 (foreground) and 249 are located approximately 100 feet apart from each other at the northeast corner of the Santa Barbara Airport.

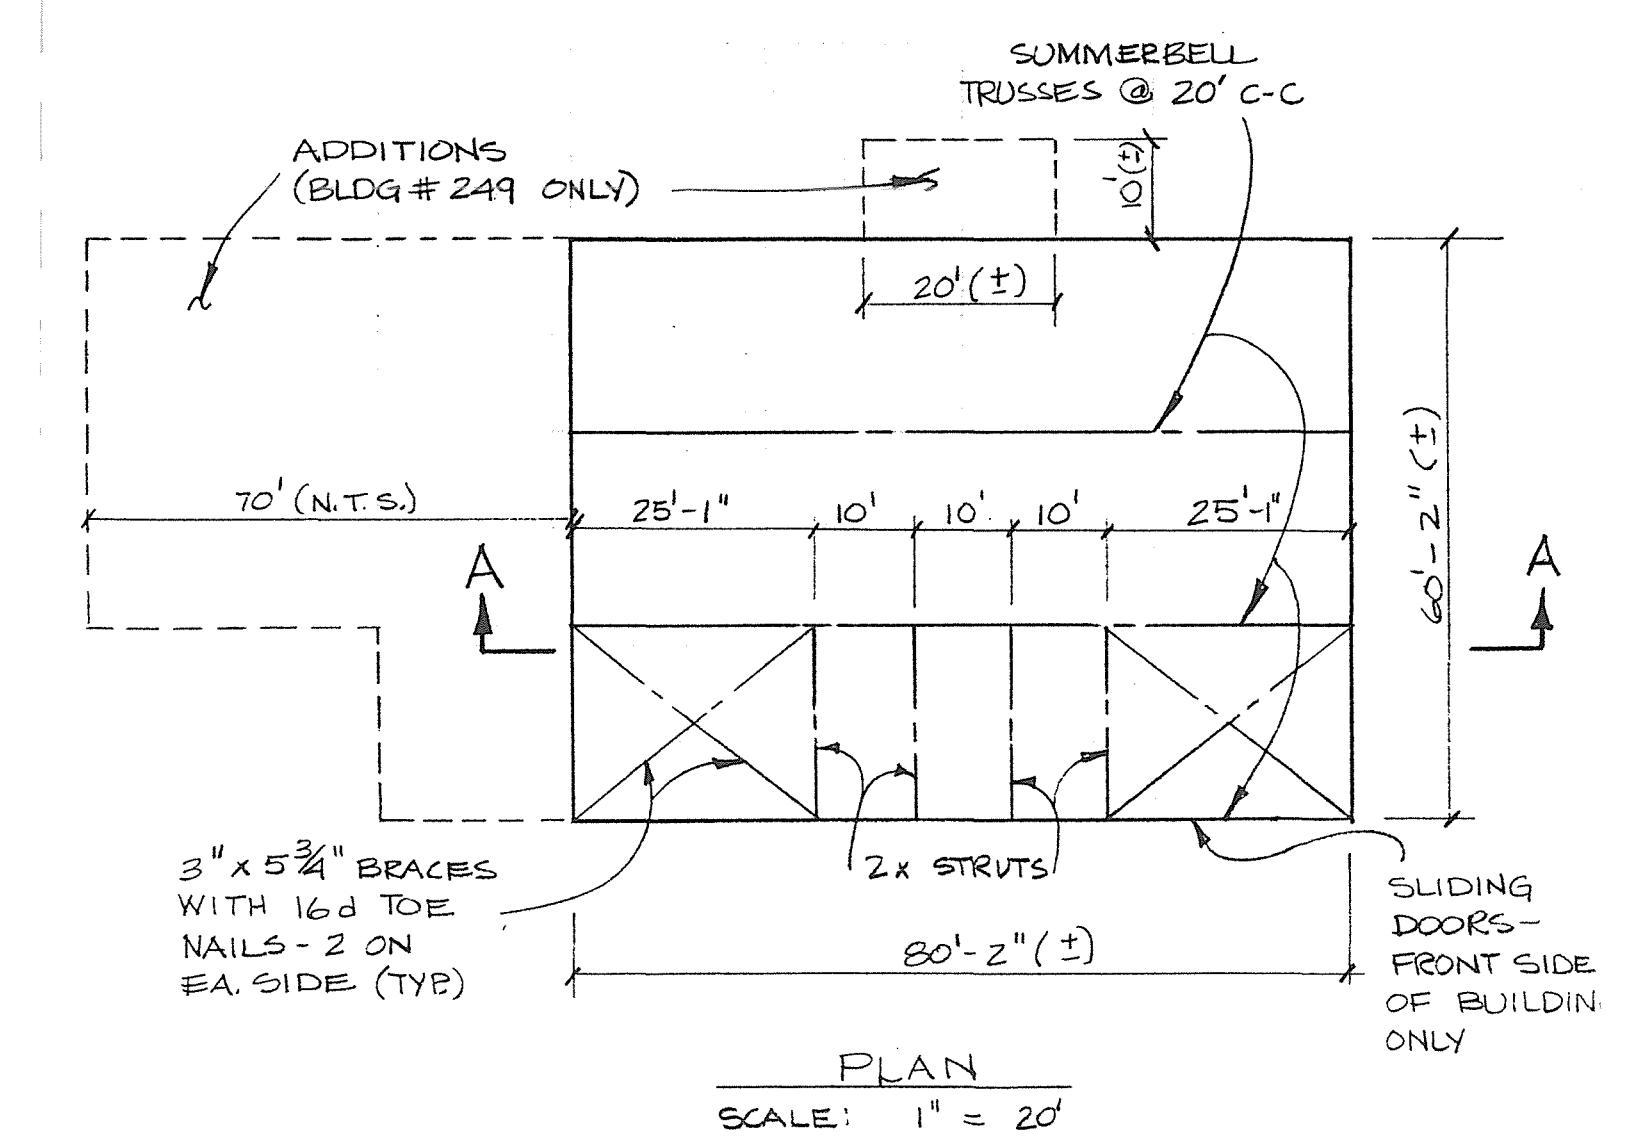
FIGURE 2

Buildings 248 and 249 are both aircraft hangar type structures with wood stud walls and a curved roof supported by wood trusses at the front and intermediate locations in the buildings, as shown in Figure 2. The trusses support 2x8 wood purlins which in turn support sheet metal roofing. Sheathing at the walls of the buildings is flat metal siding, 20 gage.

- 5. Epoxy injection for slab cracking in Hangar 249.
- 6. Add diaphragm for shear transfer at roof (plywood or sheet metal).
- 7. Add connectors for roof to wall shear transfer.
- 8. Add shear panels at walls (plywood or metal).
- 9. Add anchor bolts or other shear transfer devices at wall bottom plates.
- 10. Add connectors at bottom of columns to footings.
- 11. Improve connections for 3 X 6 X-braces at roof near front of buildings.

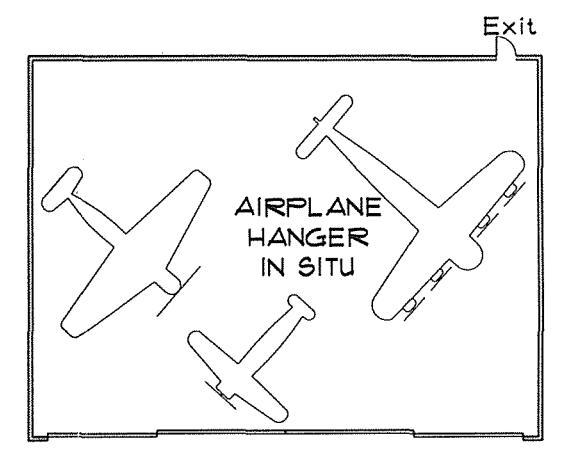
Hanger Doors <u>Bldg# 248</u>

(STRUCTURAL SAFETY RESTORATION ONLY IN SAME LOCATION)
