# Appendix A: Pipe Conditions Assessment

## SBA Master Drainage Plan

SBA Master Drainage Plan  
04.04.2023 to 04.26.2024

## CCTV Inspections

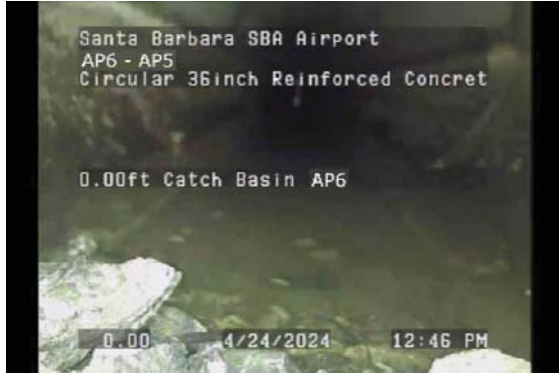
**0.00ft**  
**Catch Basin / AP6**

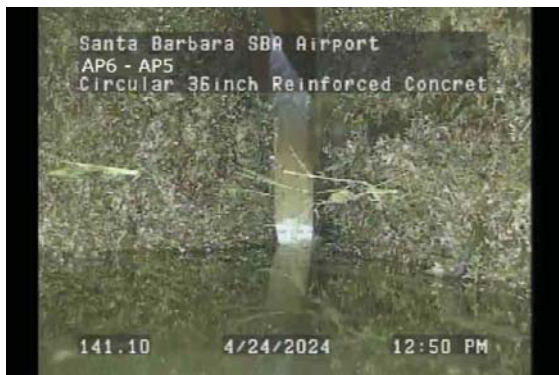
**141.10ft**  
**Discharge Point / AP5**

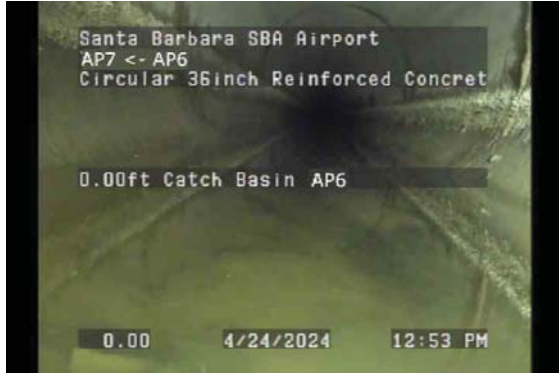
**0.00ft  
Catch Basin / AP6**

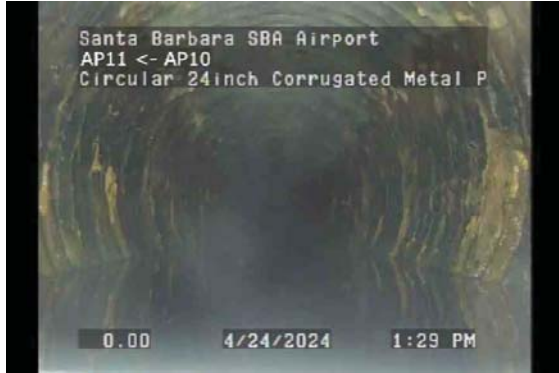
**0.00ft**  
**Catch Basin / AP10**

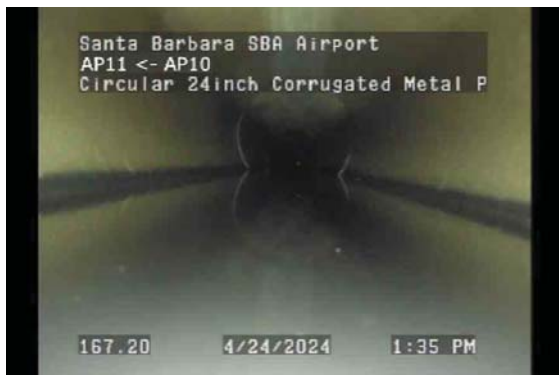
**167.20ft**  
Miscellaneous Material Change,  
Reinforced concrete pipe / RCP

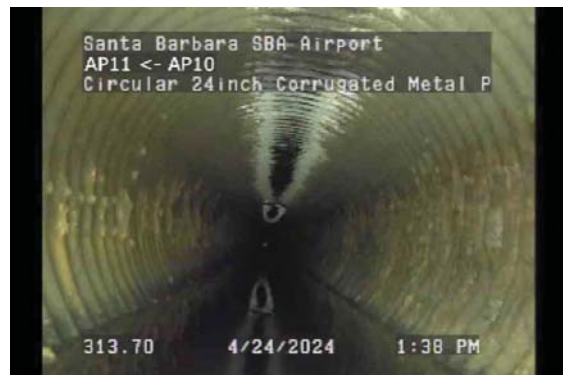
**313.70ft**  
Miscellaneous Material Change,  
Corrugated metal pipe / CMP

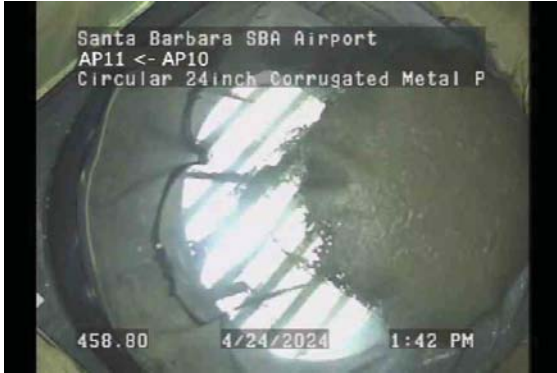
**458.80ft**  
**Catch Basin / AP11**

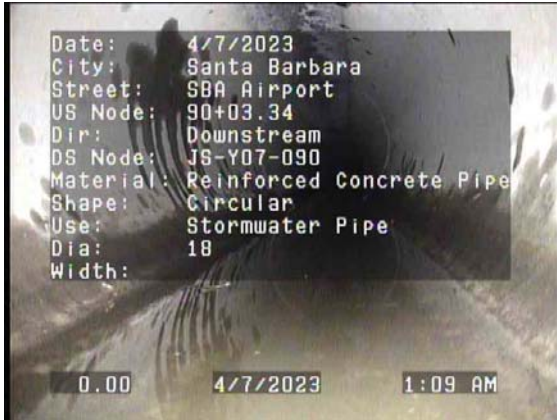
**0.00ft**  
**Catch Basin / 90+03.34**

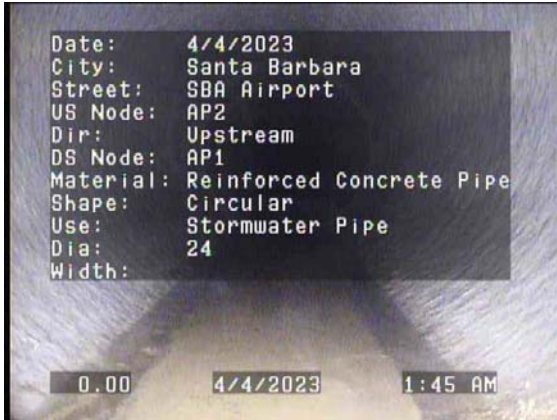
**0.00ft**  
Catch Basin / AP1

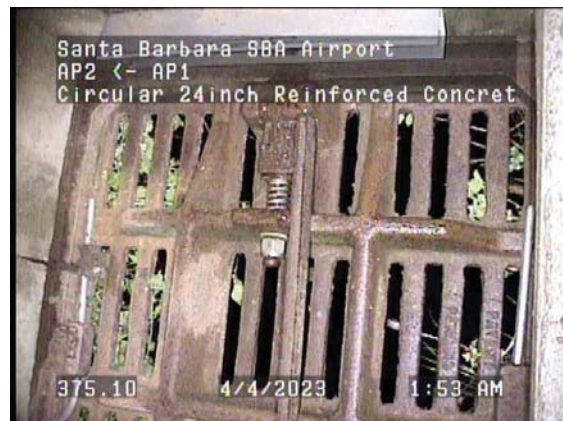
**375.10ft**  
Catch Basin / AP2

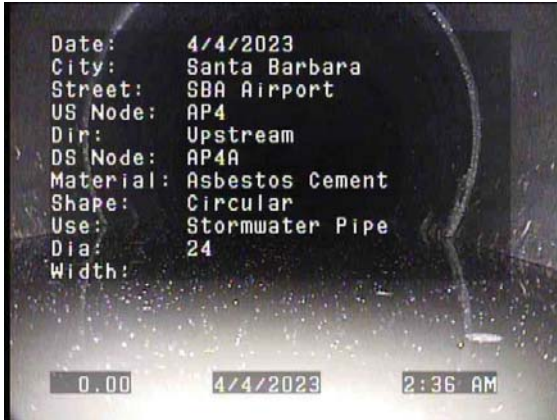
**0.00ft**  
**Catch Basin / AP4A**

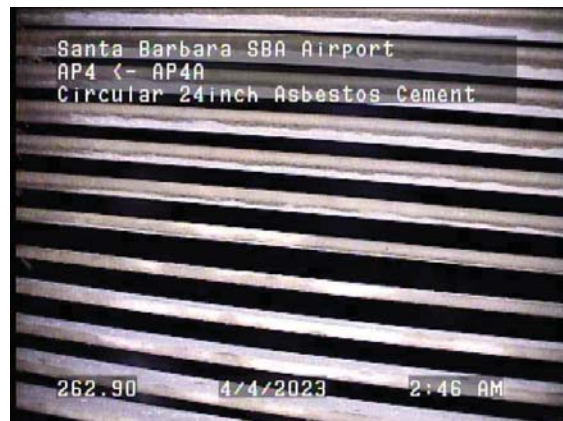
**262.90ft**  
**Catch Basin / AP4**

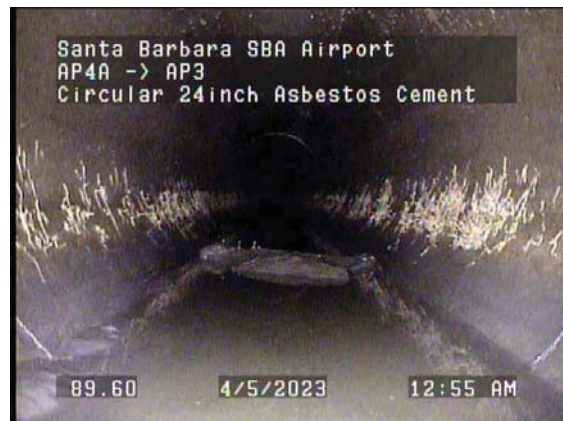
**89.60ft**  
Deposits Settled Other, 10% of cross sectional area from 5 o'clock to 7 o'clock / Debris

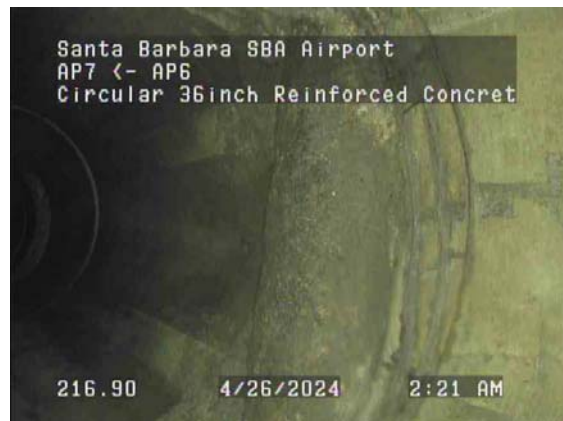
**216.90ft**  
**Obstruction Intruding Through Wall, 10% of cross sectional area from 11 o'clock to 1 o'clock, within 8 inch**

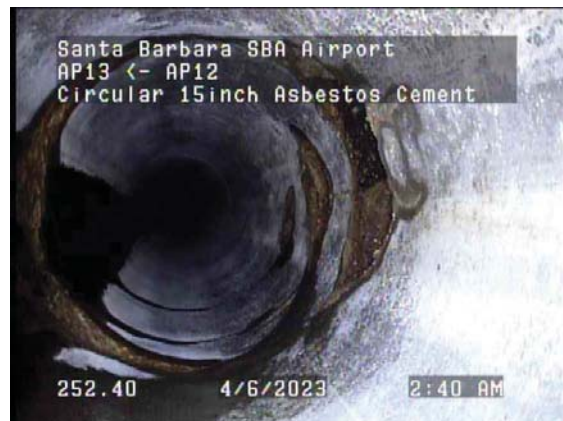
**252.40ft**  
**Hole from 11 o'clock to 1 o'clock, within 8 inch**

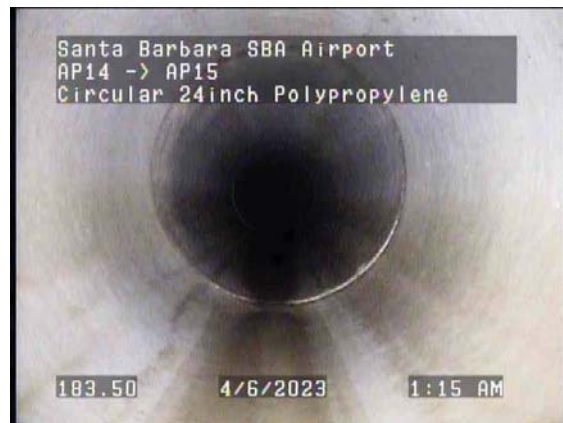
**183.50ft**  
**Miscellaneous Material Change, Asbestos cement / ACP**

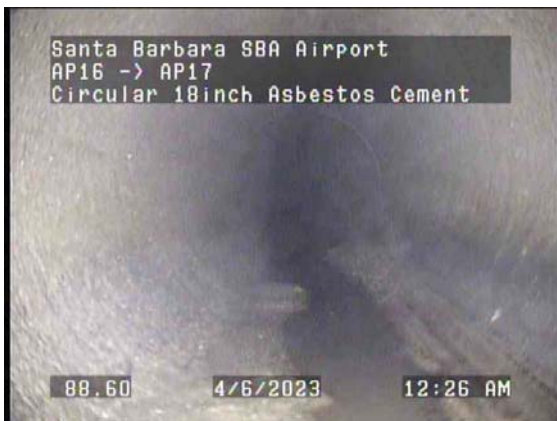
**88.60ft**  
**Deposits Settled Other, 5% of cross sectional area from 5 o'clock to 7 o'clock, Start / Debris**

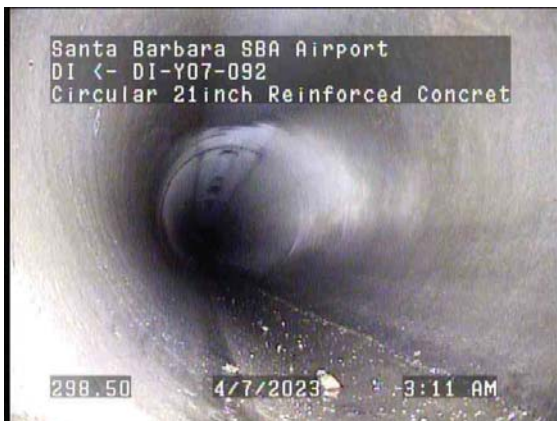
**298.50ft**  
**Tap Break-in/Hammer at 9 o'clock, dia/height: 18inch**

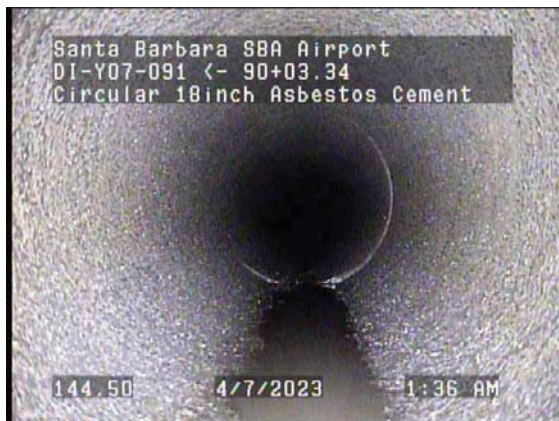
**144.50ft**  
Deposits Settled Other, 5% of cross sectional area from 5 o'clock to 7 o'clock, Finish / Debris

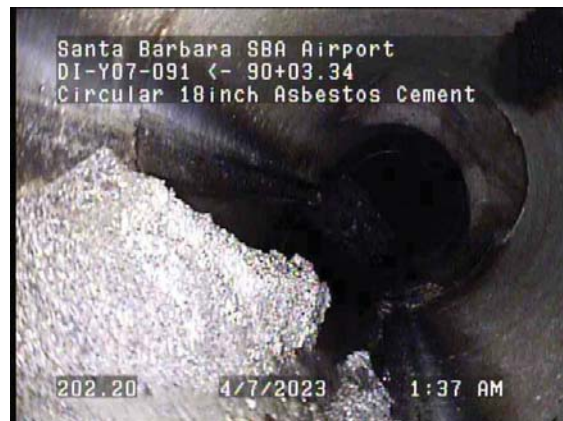
**202.20ft**  
Deposits Settled Other, 10% of cross sectional area from 5 o'clock to 7 o'clock / Debris

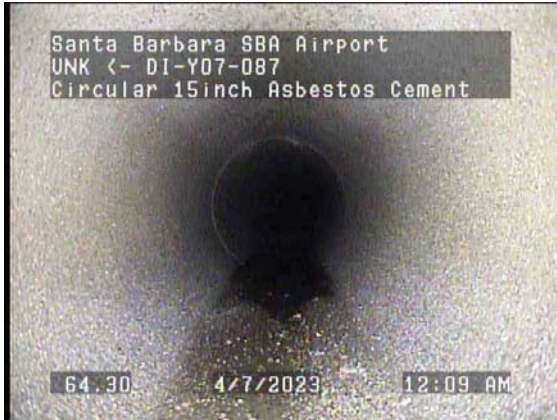
**64.30ft**  
Deposits Settled Other, 5% of cross sectional area from 5 o'clock to 7 o'clock / Debris

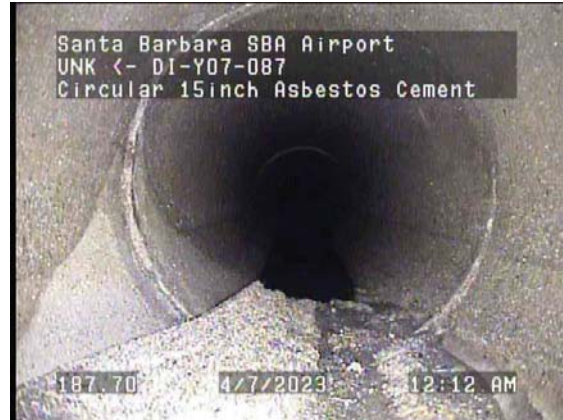
**187.70ft**  
Deposits Settled Other, 10% of cross sectional area from 5 o'clock to 7 o'clock / Debris

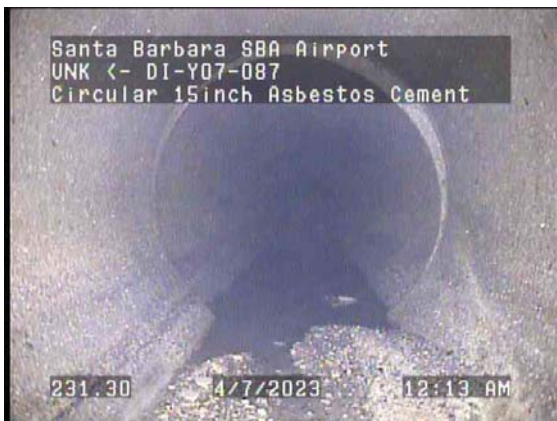
**231.30ft**  
Deposits Settled Other, 5% of cross sectional area from 5 o'clock to 7 o'clock / Debris

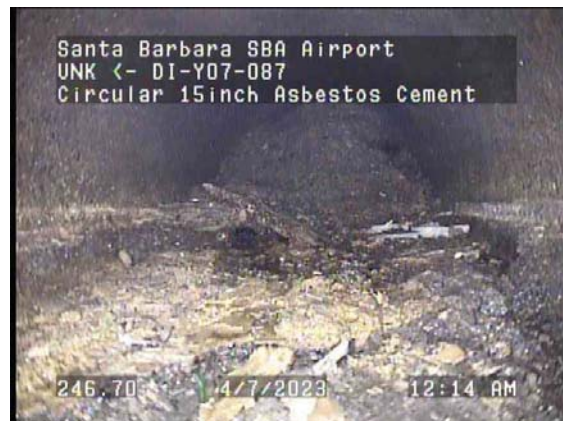
**246.70ft**  
Deposits Settled Compacted, 50% of cross sectional area from 3 o'clock to 9 o'clock / Concrete

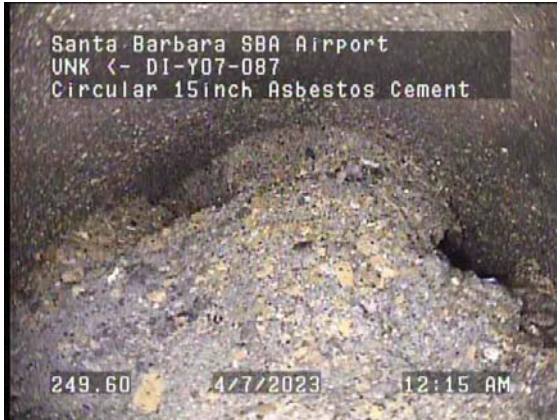
**249.60ft**  
Deposits Settled Compacted, 100% of cross sectional area from 12 o'clock to 12 o'clock / Concrete
