# Appendix A: Pipe Conditions Assessment

## SBA Master Drainage Plan

SBA Master Drainage Plan  
04.04.2023 to 04.26.2024

## CCTV Inspections

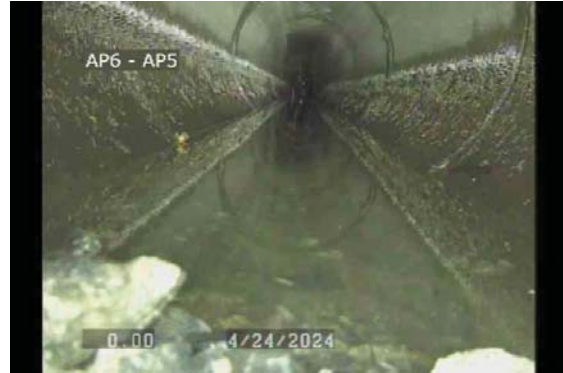
**0.00ft**  
**Water Level, 5% of the vertical dimension**

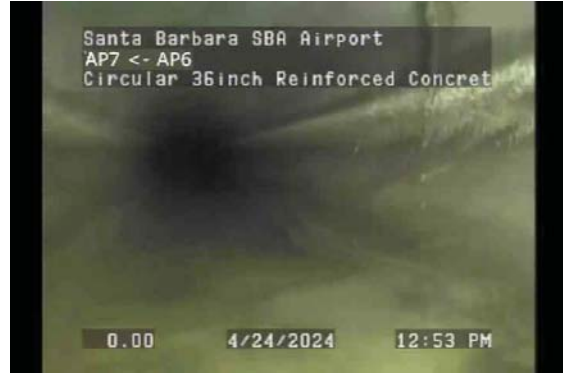
**0.00ft  
Water Level, 10% of the vertical  
dimension**

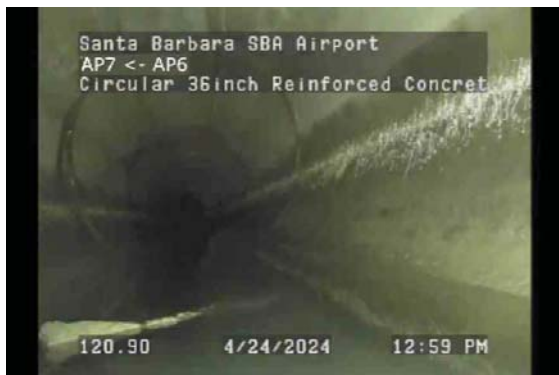
**120.90ft  
Miscellaneous Survey Abandoned / OBR**

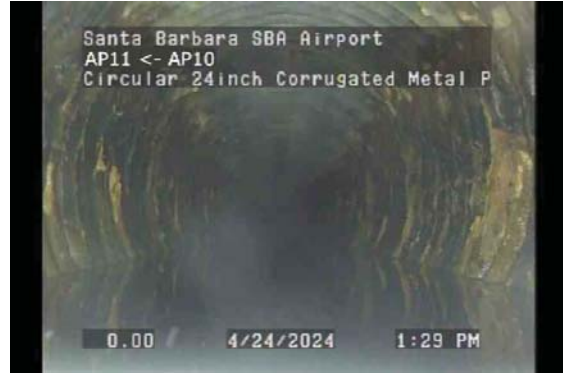
**0.00ft**  
**Water Level, 20% of the vertical dimension**

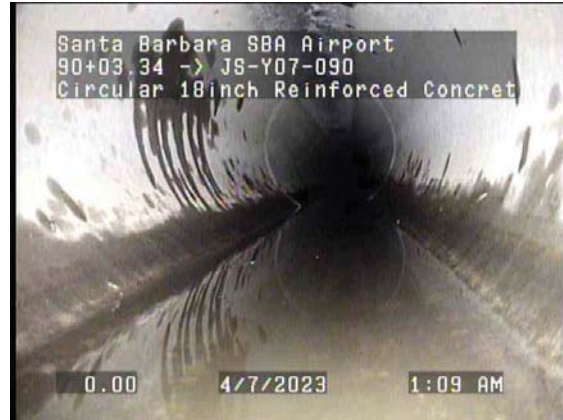
**0.00ft**  
**Water Level, 10% of the vertical dimension**

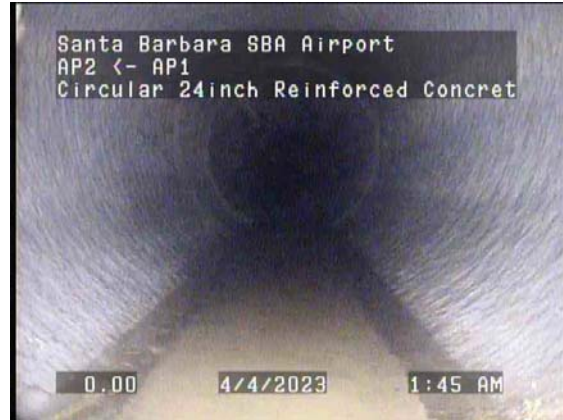
**0.00ft**  
Water Level, 5% of the vertical dimension

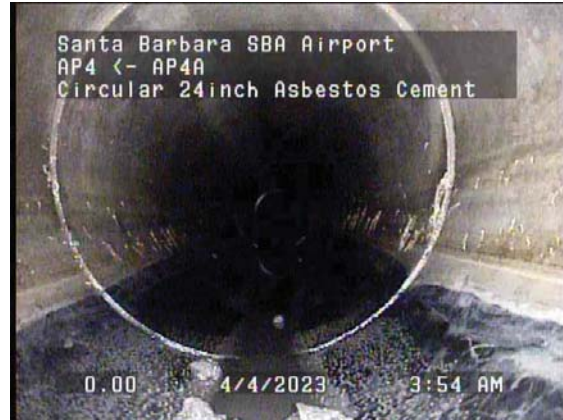
**0.00ft**  
**Water Level, 5% of the vertical dimension**

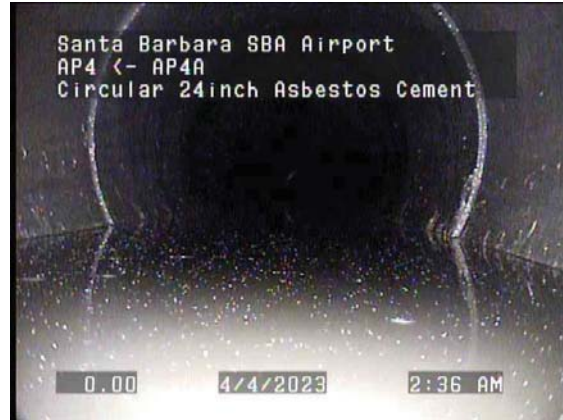
**0.00ft**  
**Water Level, 20% of the vertical dimension**

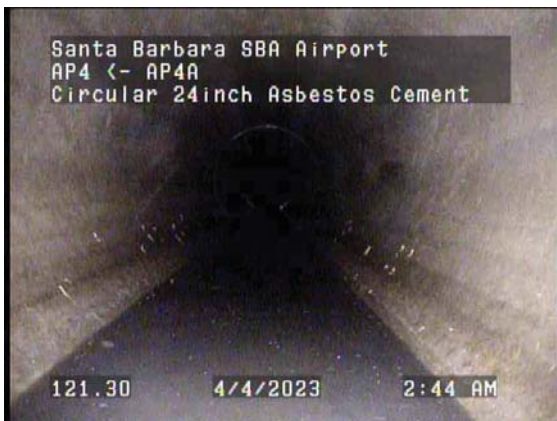
**121.30ft**  
**Water Level, 10% of the vertical dimension**

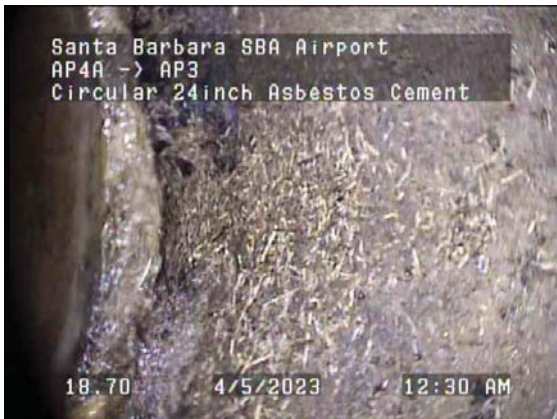
**18.70ft**  
**Joint Offset Medium**

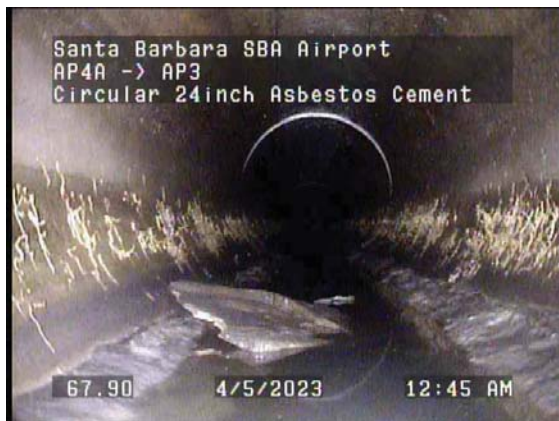
**67.90ft**  
Water Level, 5% of the vertical dimension

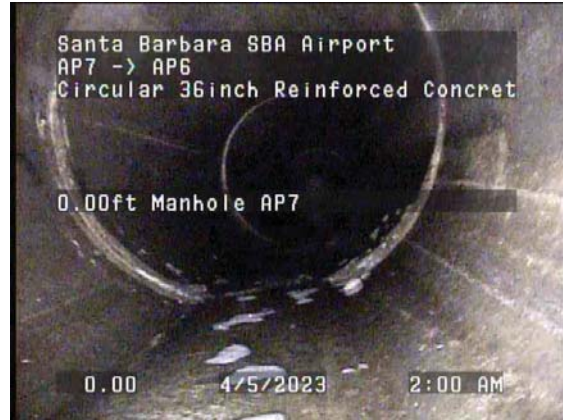
**0.00ft**  
**Water Level, 5% of the vertical dimension**

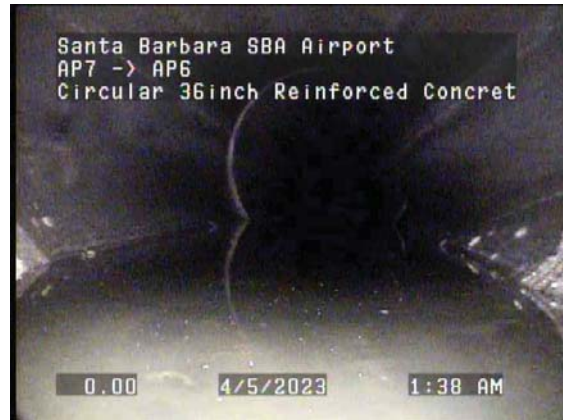
**0.00ft**  
**Water Level, 20% of the vertical dimension**

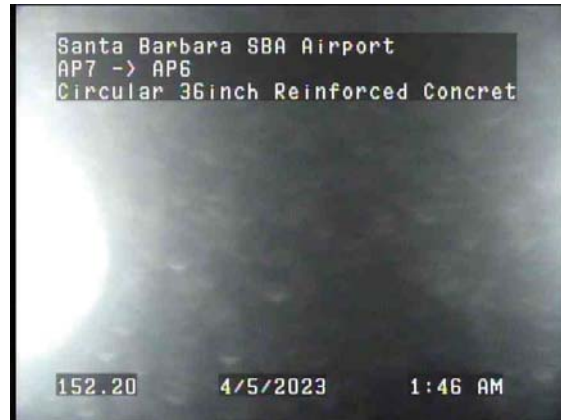
**152.20ft**  
**Miscellaneous Camera Underwater**

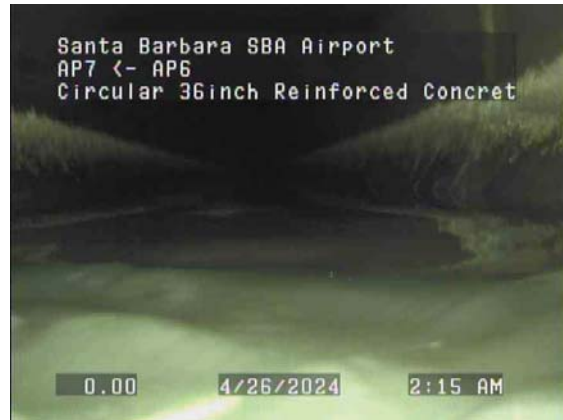
**0.00ft**  
**Water Level, 15% of the vertical dimension**

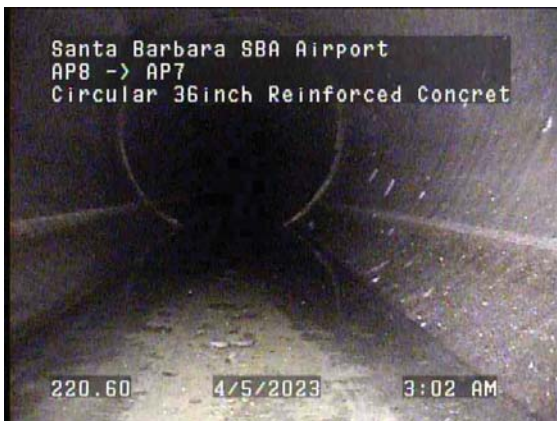
**220.60ft**  
**Miscellaneous Water Mark, 20% of the vertical dimension**

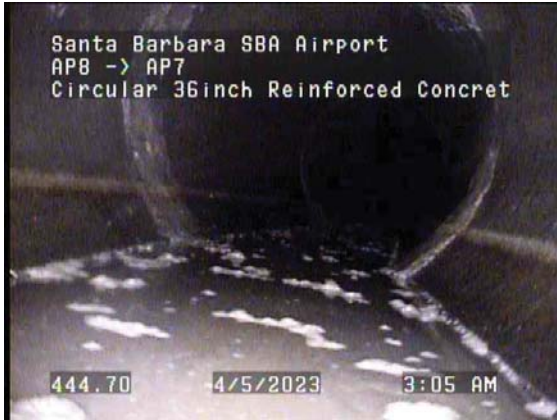
**444.70ft**  
**Line Right, change to: 5%**

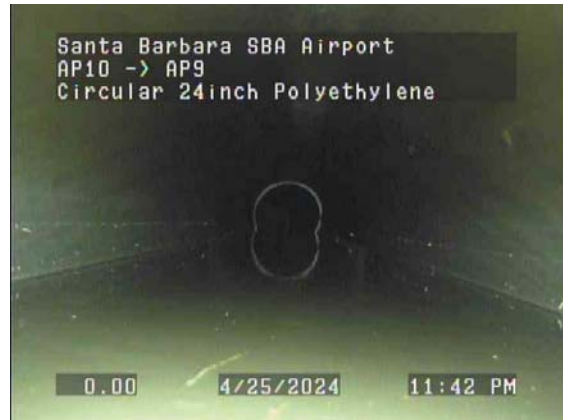
**0.00ft**  
**Water Level, 20% of the vertical dimension**

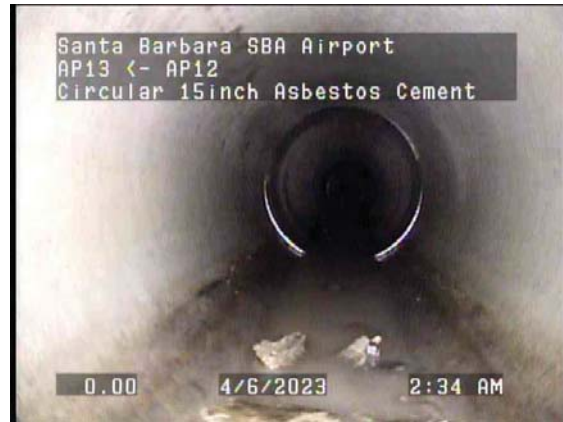
**0.00ft**  
**Water Level, 5% of the vertical dimension**

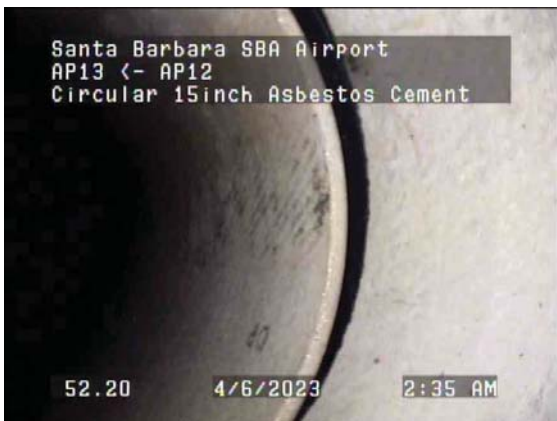
**52.20ft**  
**Joint Offset Medium**

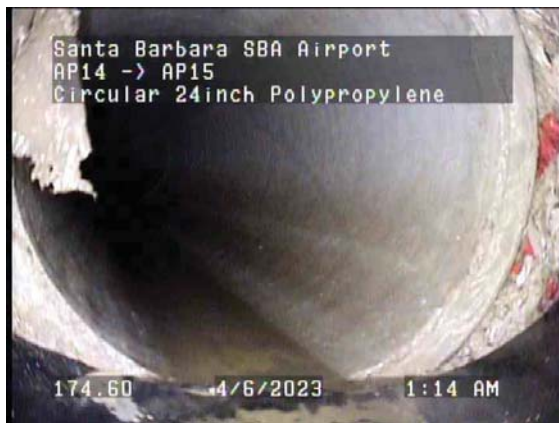
**174.60ft**  
**Joint Angular Medium**

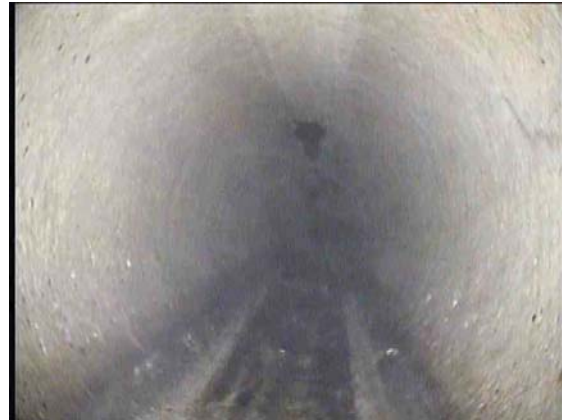
**0.00ft**  
**Water Level, 5% of the vertical dimension**

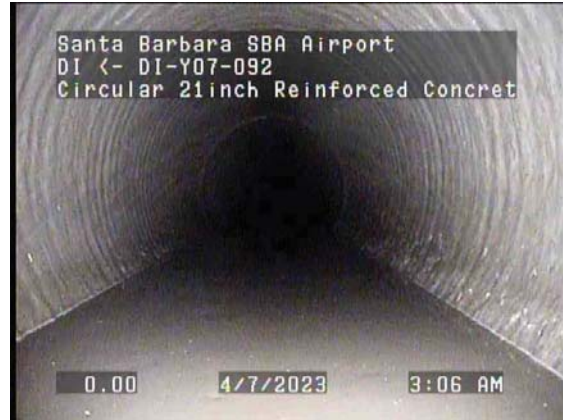
**0.00ft**  
**Water Level, 10% of the vertical dimension**

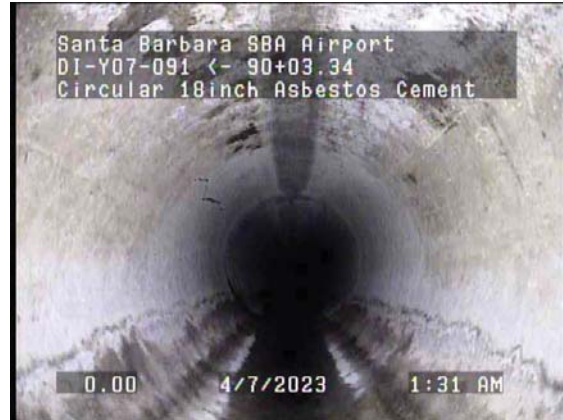
**0.00ft**  
**Water Level, 5% of the vertical dimension**

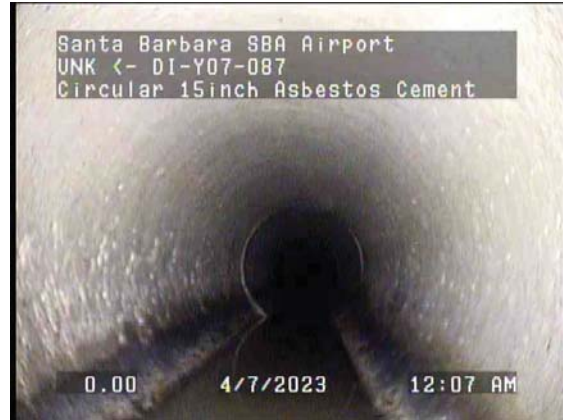
**0.00ft**  
**Water Level, 5% of the vertical dimension**

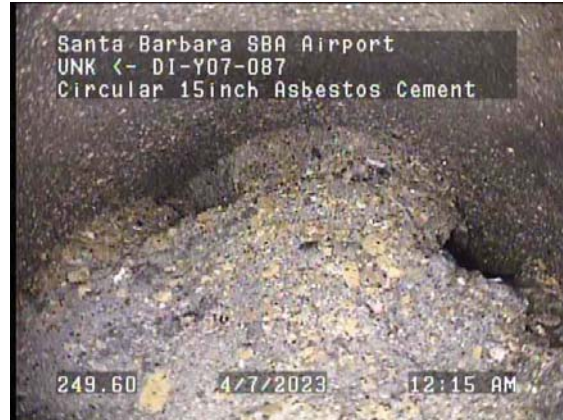
**249.60ft**  
Miscellaneous Survey Abandoned / DSC
